# Property Evaluation Report

**Property Address** 2804 Goldfinch Dr Mesquite TX 75181-4923

**Evaluated By** Trung Phung  
**Evaluation Date** 15 March, 2017  
**Unit Name** GOLD2804 - (2804 Goldfinch)  
**Lease Name** DeLao - DeLao

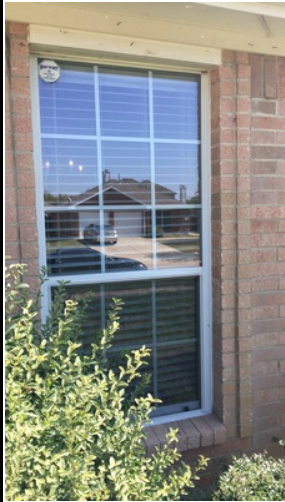
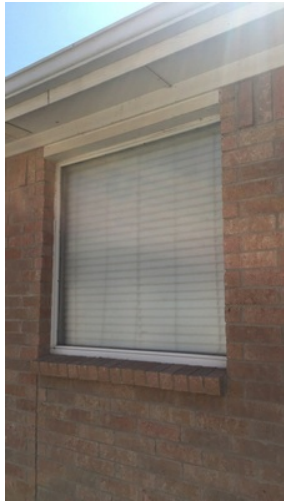
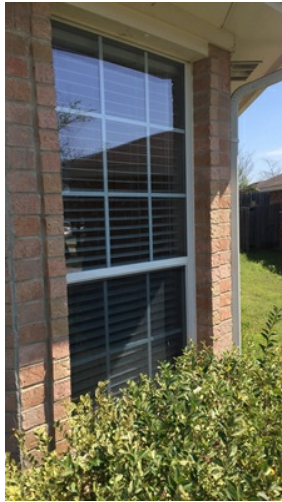
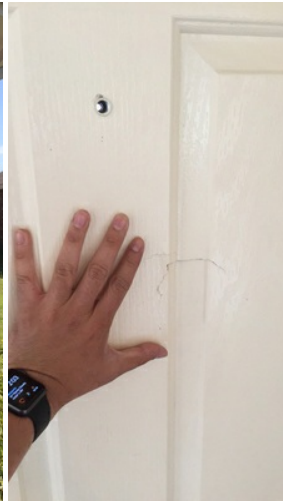
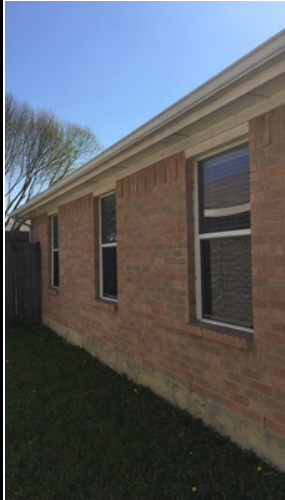
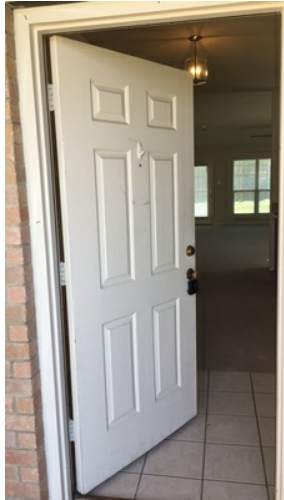
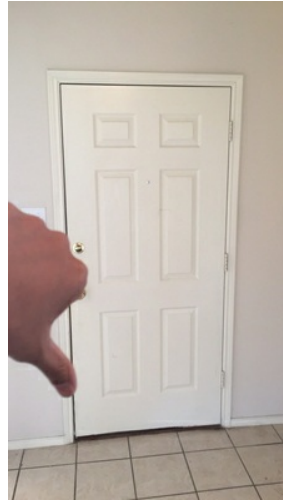
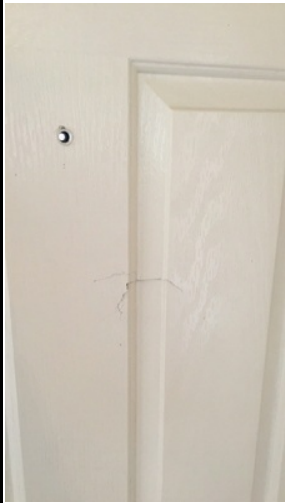
Category: EXTERIOR - Door/Windows

Condition: Repair

**Comments:** Will need to remove sticky hook off front door and repaint. All windows surrounding property are in great shape with screens.

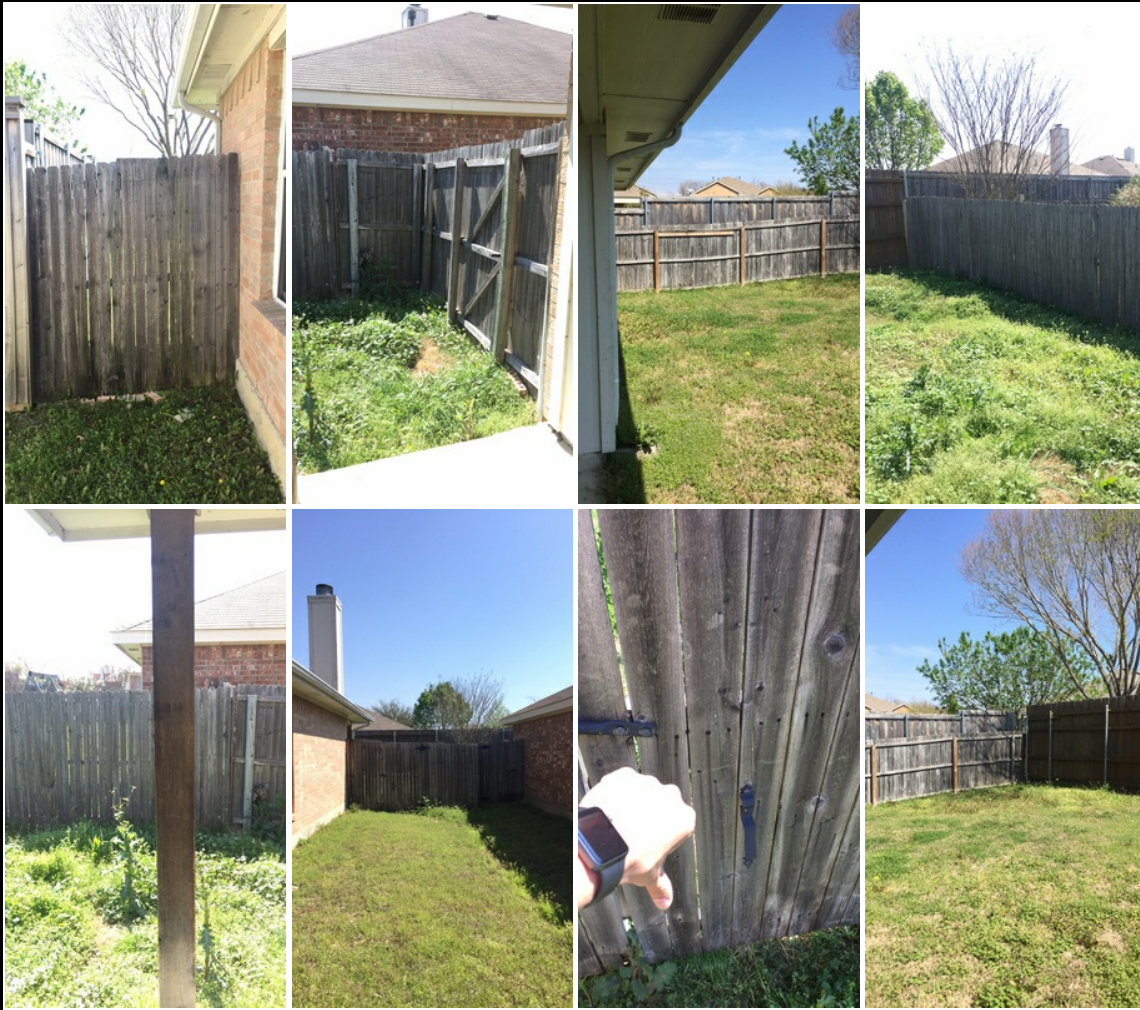
Category: EXTERIOR - Fence/Deck

Condition: OK

**Comments:** Grate handle needs to be reattached. Overall fence is standing; wood rotting. Would recommend future budgeting for fence repairs.

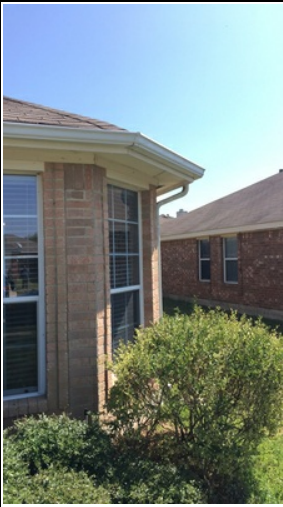
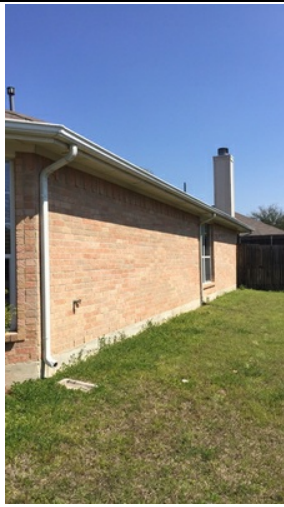
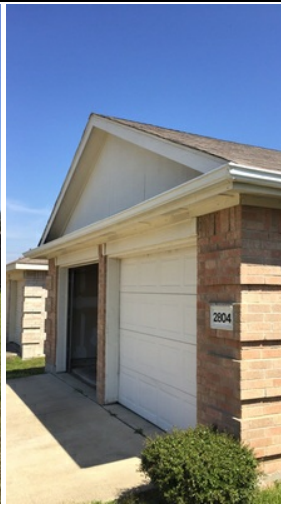
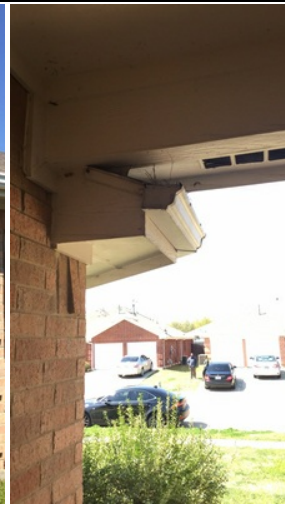
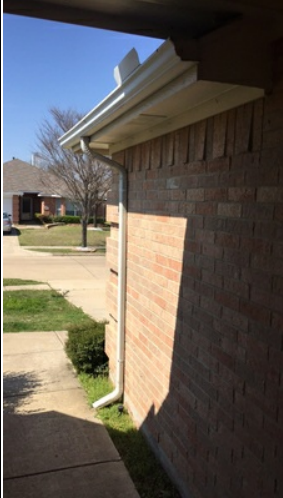
Category: EXTERIOR - Gutters

Condition: OK

Comments: Gutters are in good shape. Will need to remove birds nest in gutter on porch

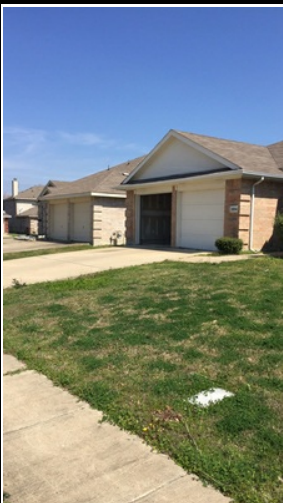
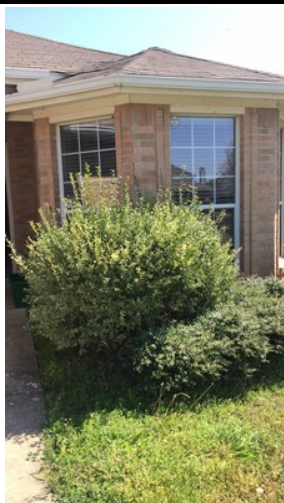
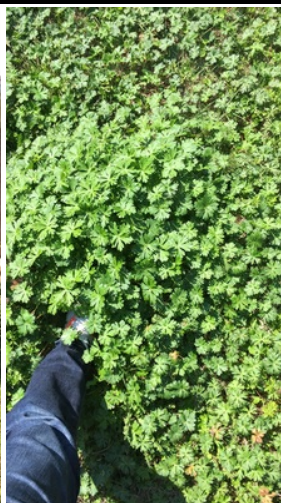
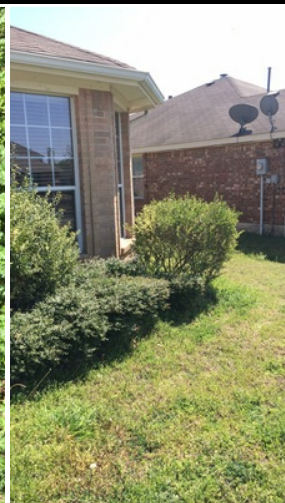
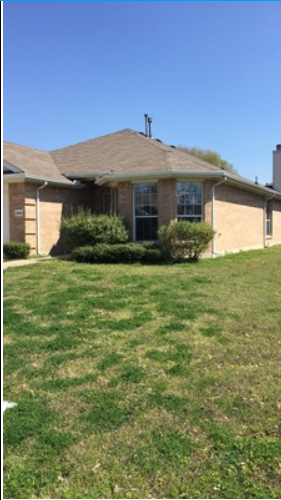
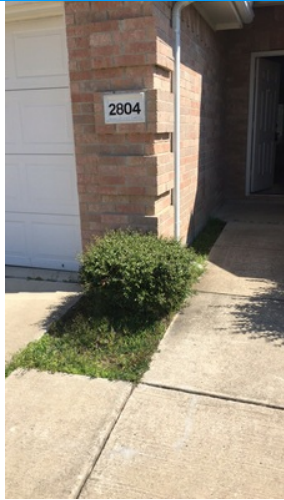
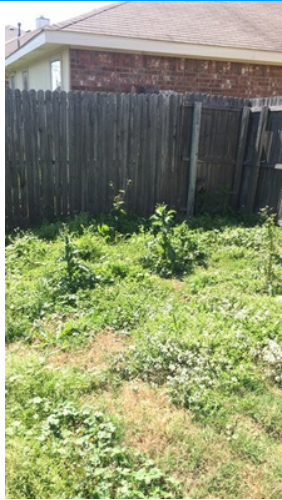
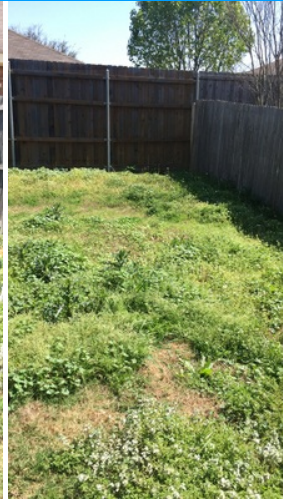
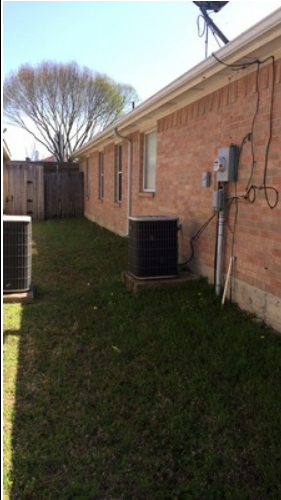
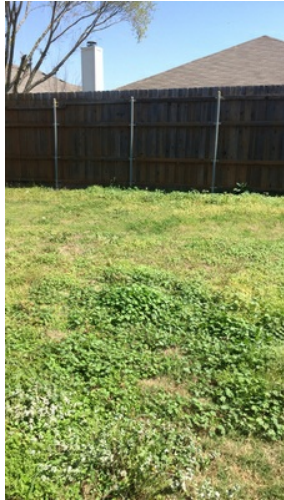
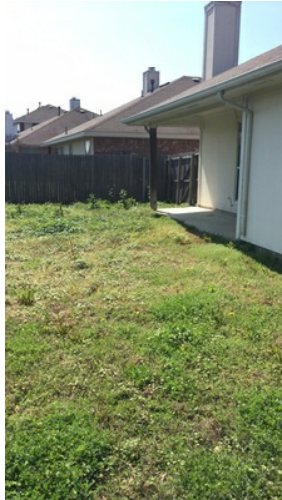
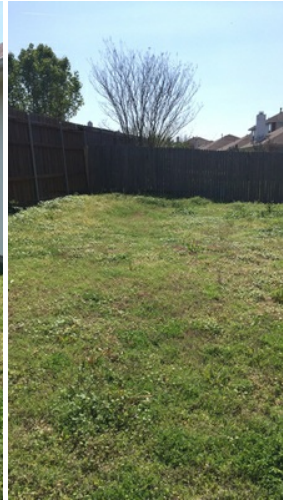
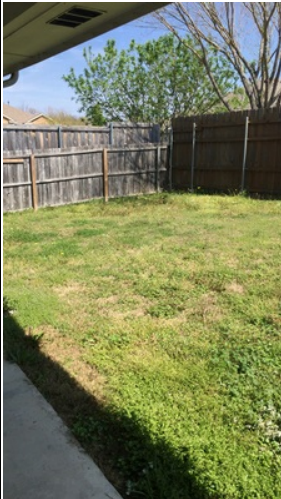
Category: EXTERIOR - Landscaping (Initial Cleanup)

Condition: Repair

**Comments:** Tenant did not perform landscaping duties prior to move out. Will need mow edge blow trim hedges remove weeds from flower bed and add red mulch.

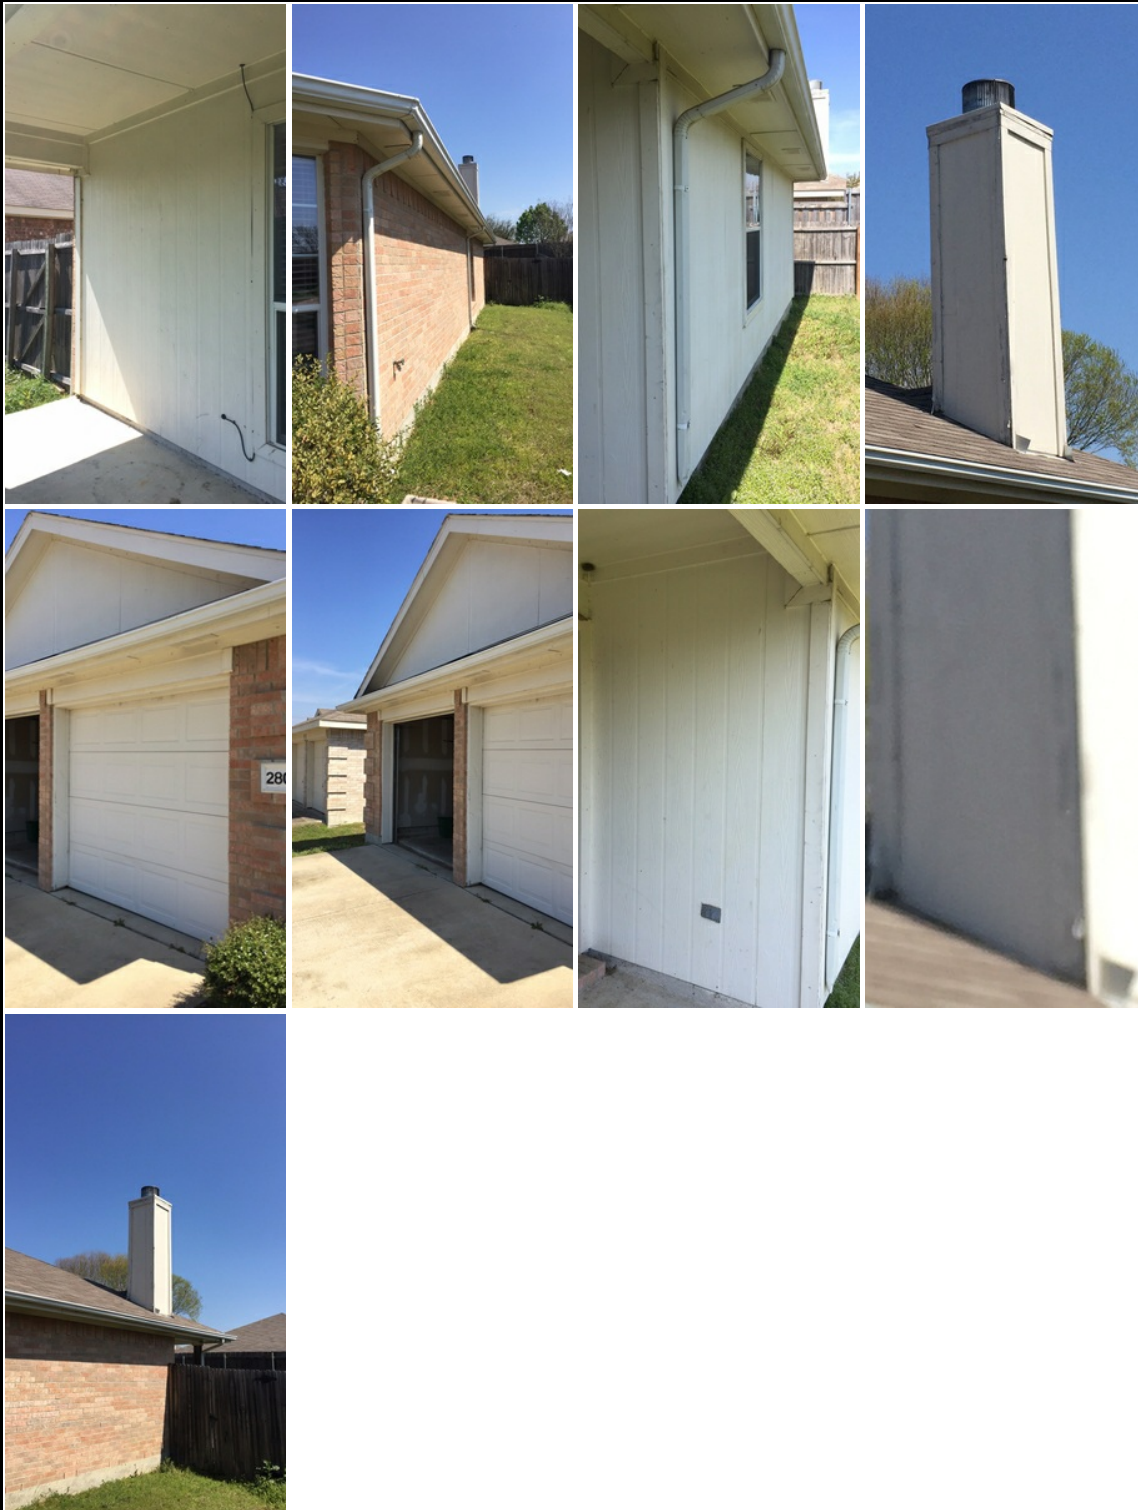
Category: EXTERIOR - Paint/Siding/Trim

Condition: Repair

**Comments:** Exterior paint looks good. Chimney paint is peeling/chipping away. Would recommend repaint.

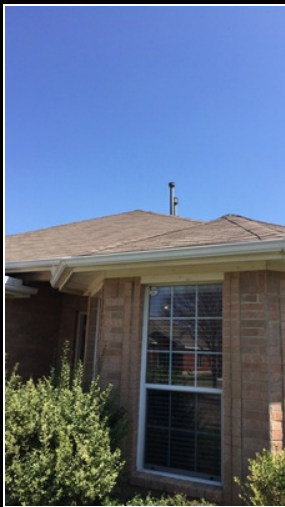
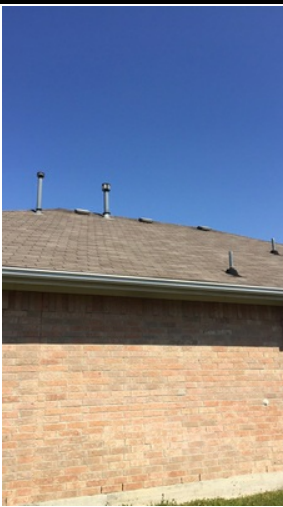
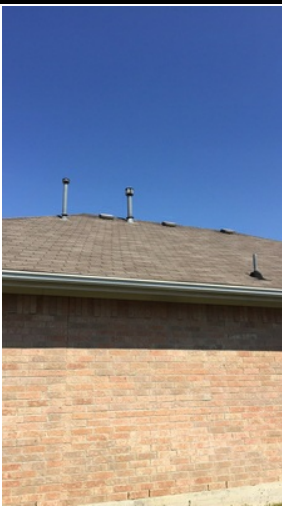
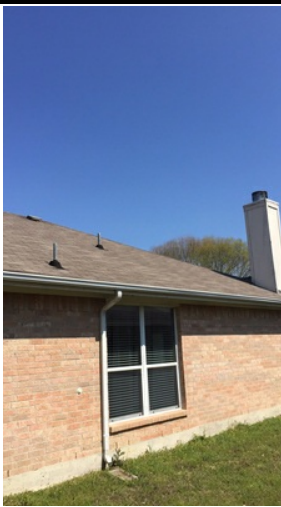
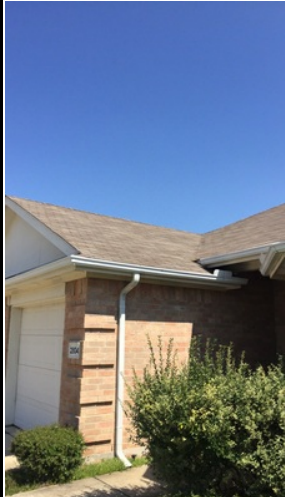
Category: EXTERIOR - Roof

Condition: OK

Comments: Roof looks good. No indication of water leaks in ceiling inside property

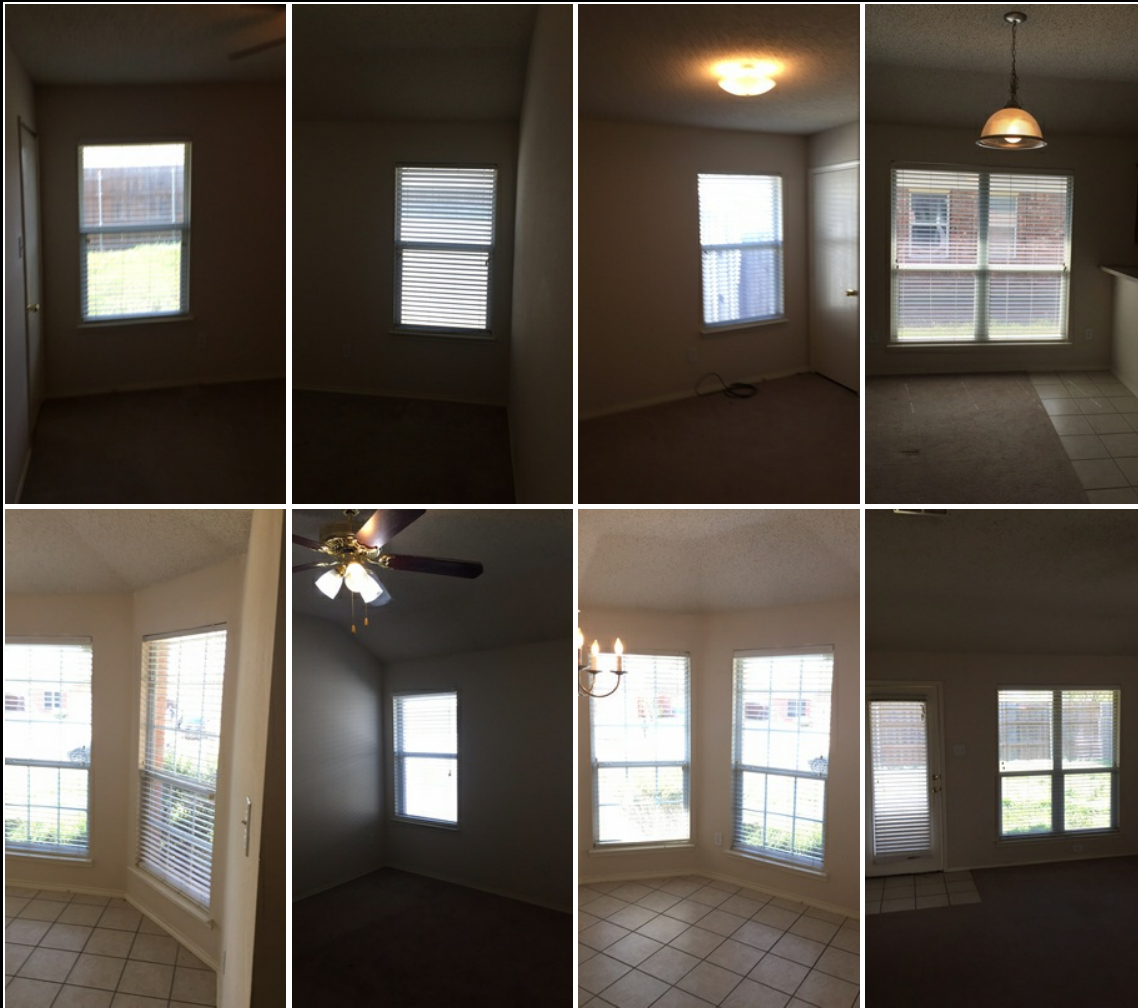
Category: INTERIOR - Blinds

Condition: OK

**Comments:** Blinds all throughout property in great shape; will need to dust and clean. Will be part of cleaning

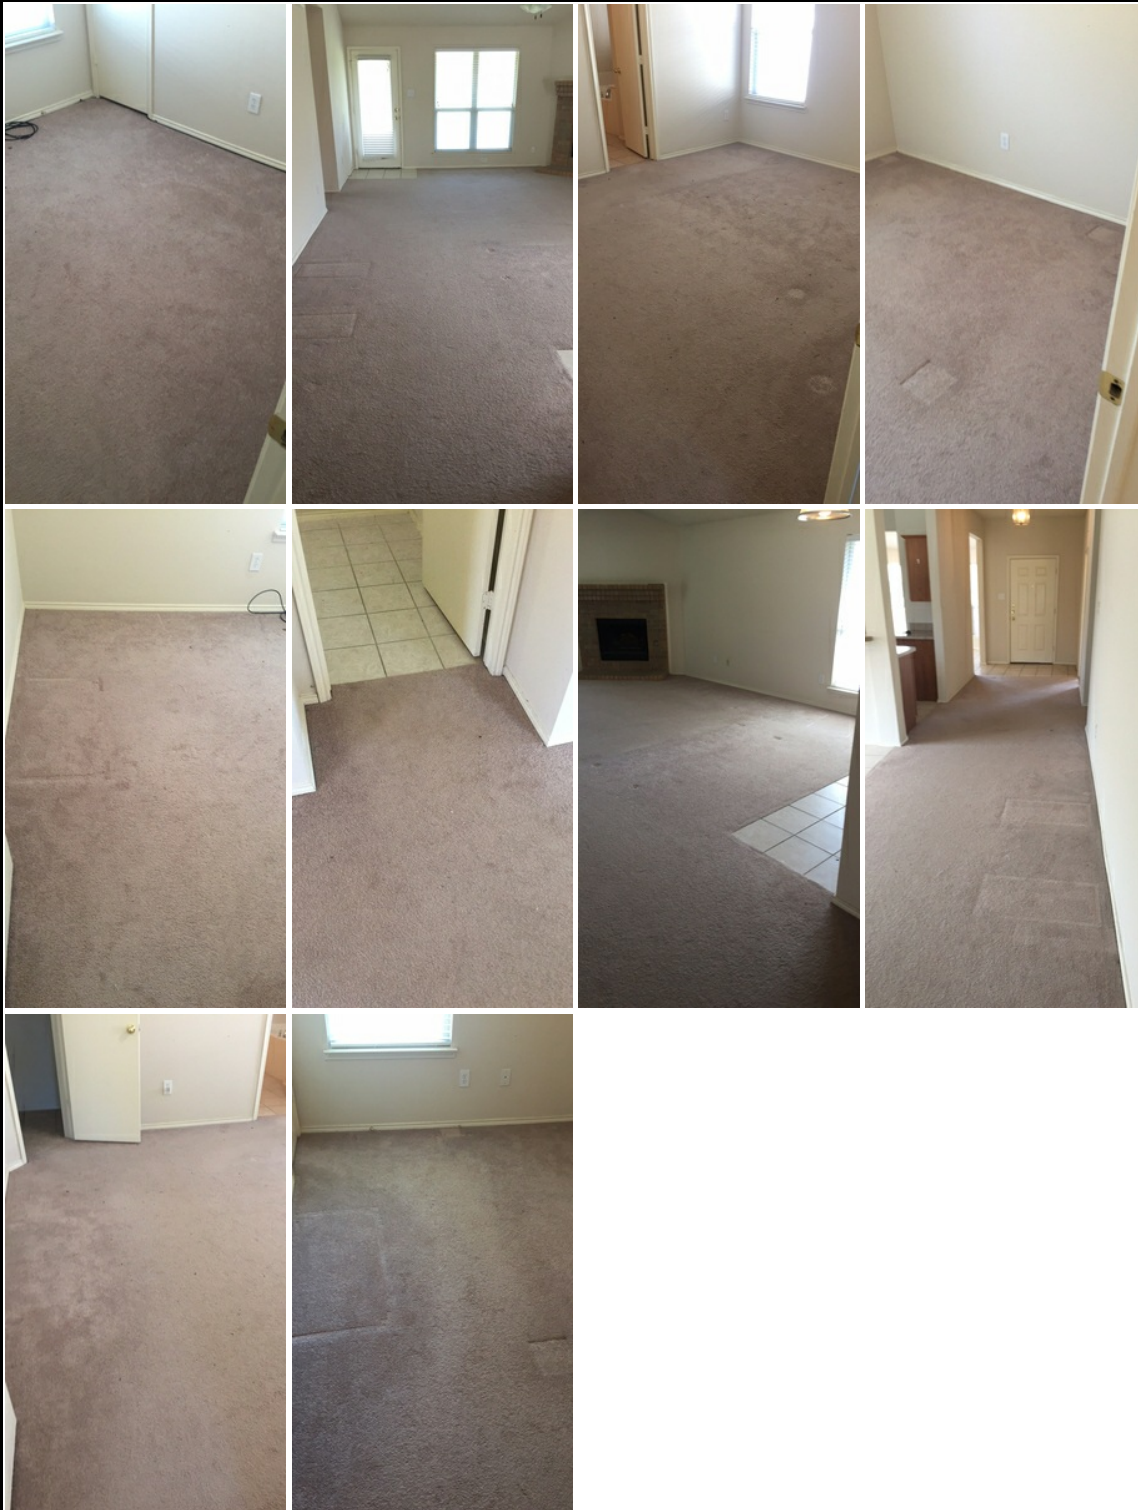
Category: INTERIOR - Carpet

Condition: OK

Comments: Carpet is in good shape. Tenant did not clean; will need shampoo during turnover.

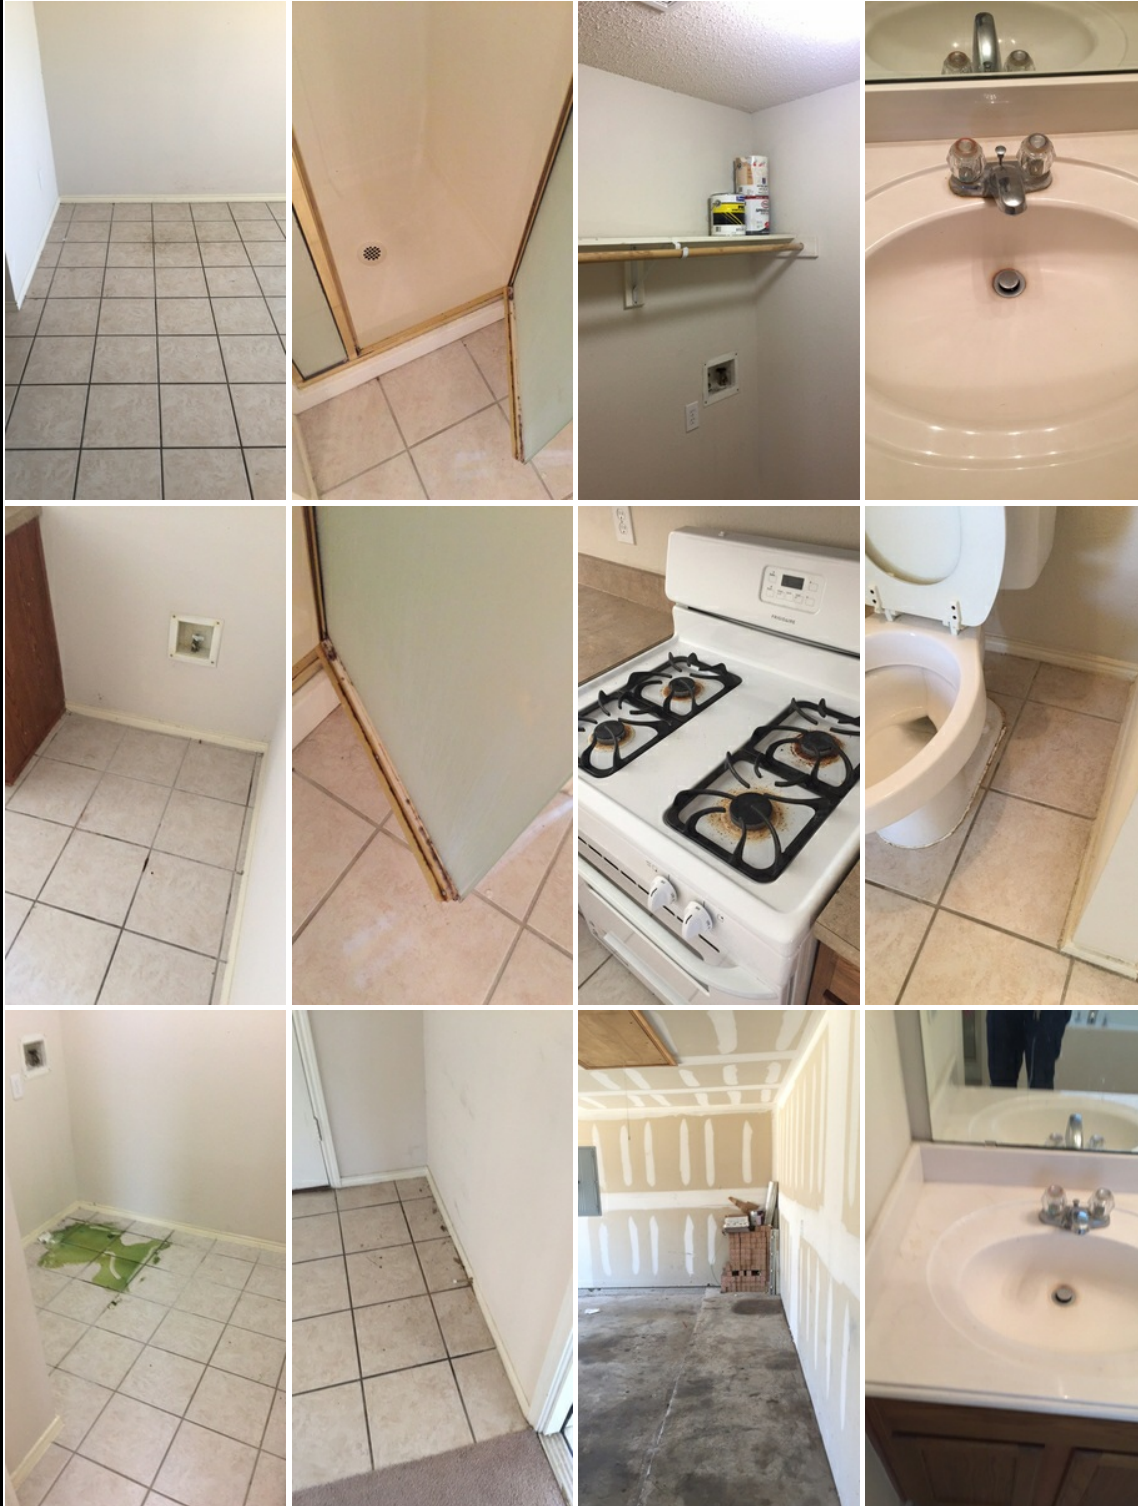
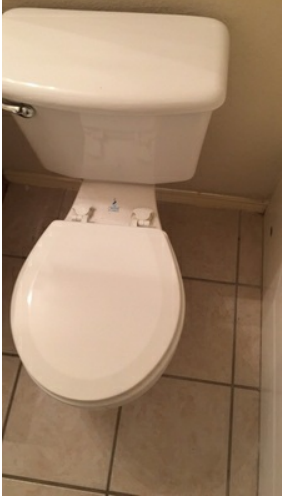
Category: INTERIOR - Cleaning

Condition: Repair

**Comments:** Tenant did not perform cleaning responsibilities prior to move out; will need final clean. Property left is overall good shape

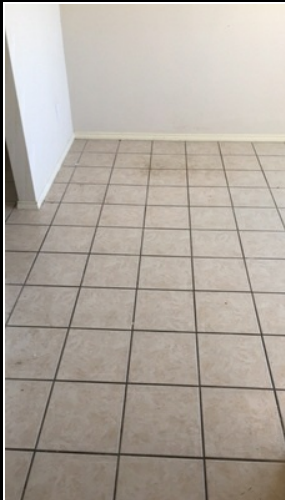
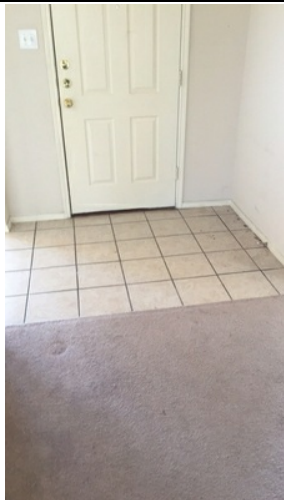
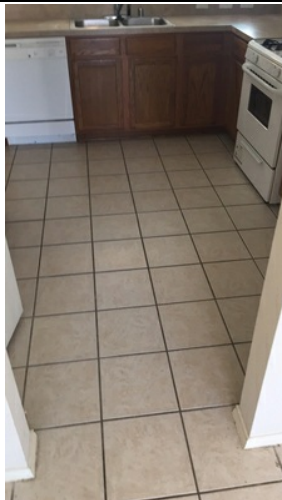
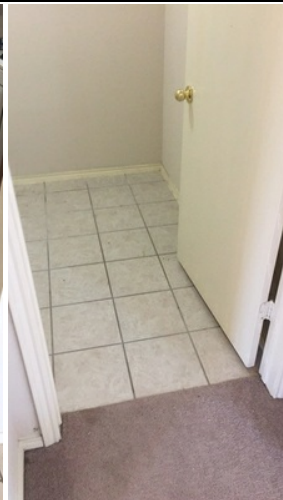
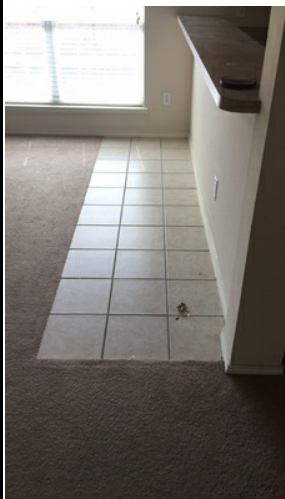
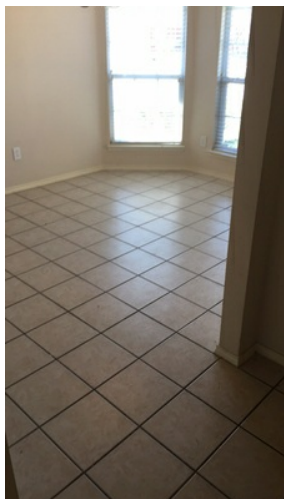
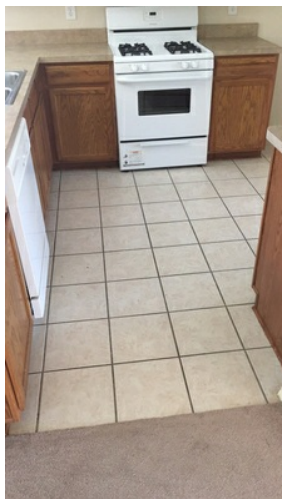
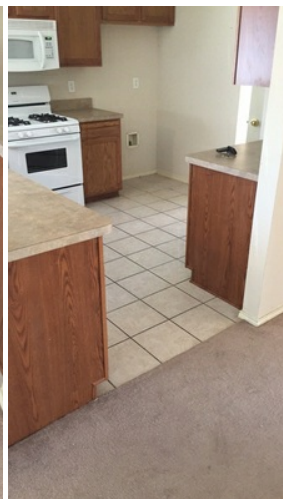
**Category:** INTERIOR - Hard Surface Flooring

**Condition:** OK

**Comments:** Tile in entry, dining room, kitchen, and bar space all in great condition.

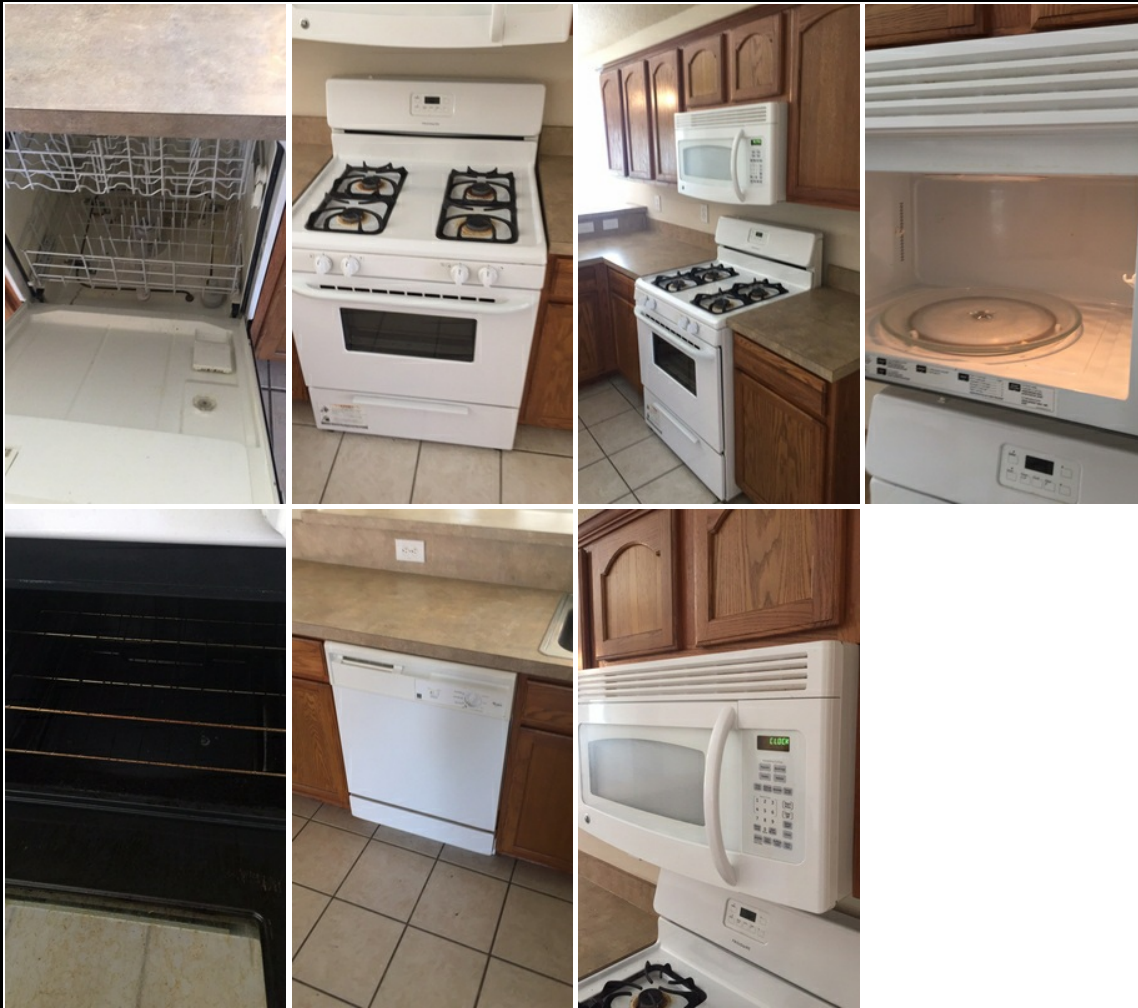
Category: INTERIOR - Kitchen Appliances

Condition: OK

Comments: All white appliances in good shape and condition

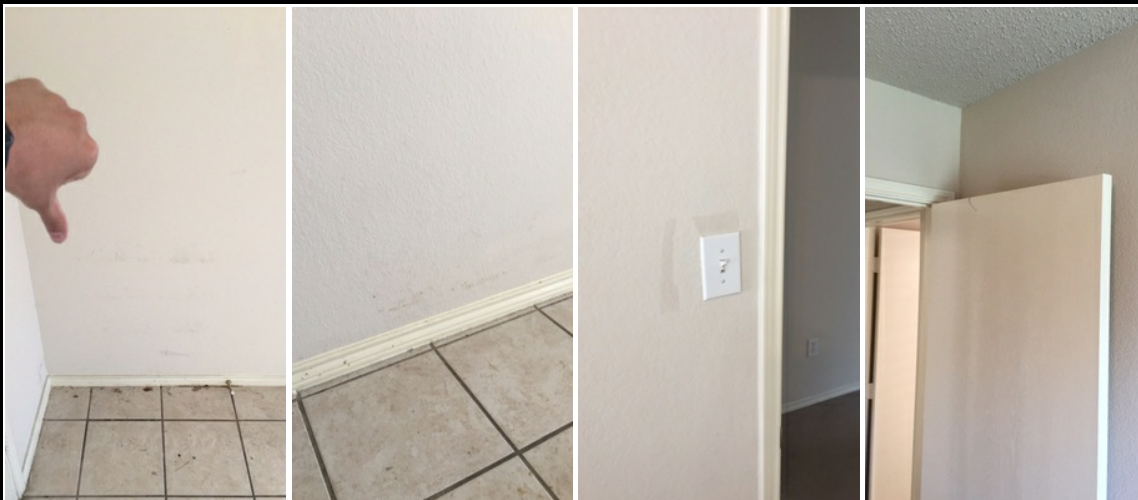
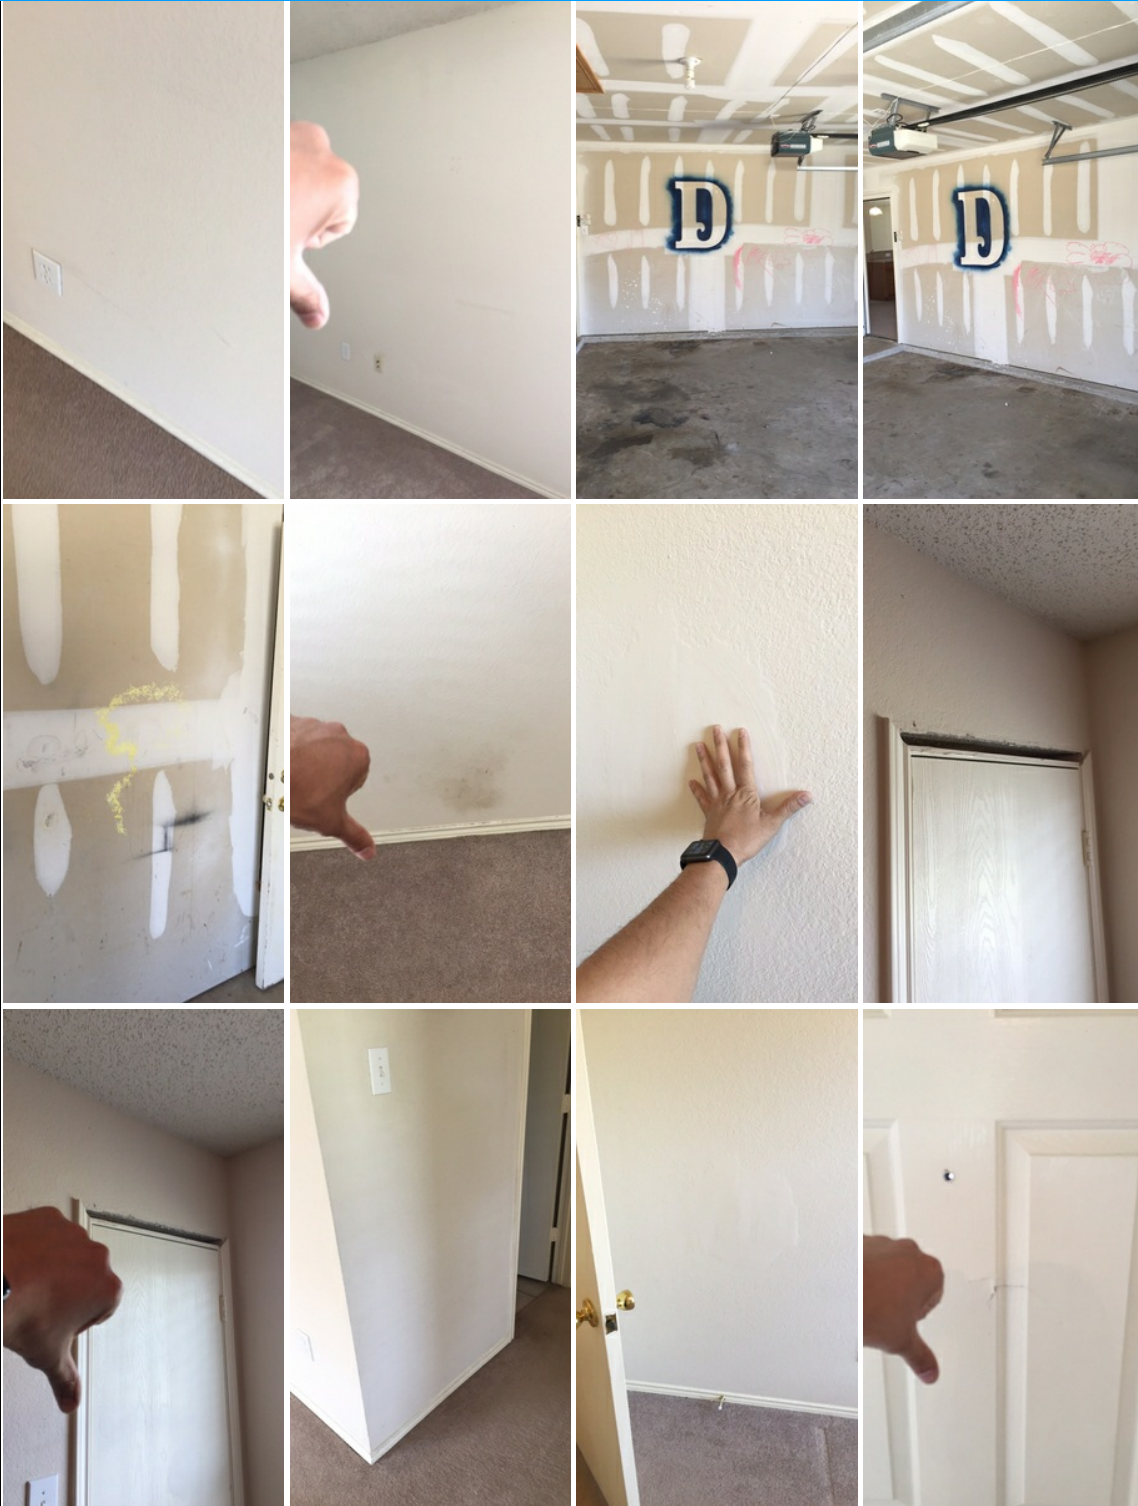
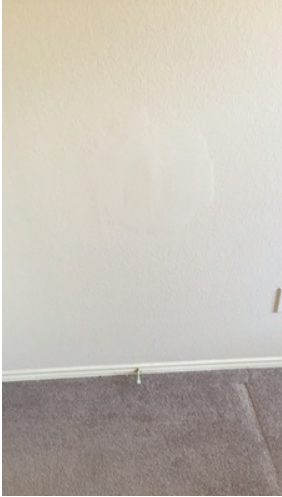
Category: INTERIOR - Paint

Condition: Repair

**Comments:** Light touch up; paint looks good. Normal wear and tear. Will need to repair in guestbedroom door; cracked top of door. Also need to repair trim for same bedroom closet door. Will need to repaint art work on garage wall; tenant chatge back.

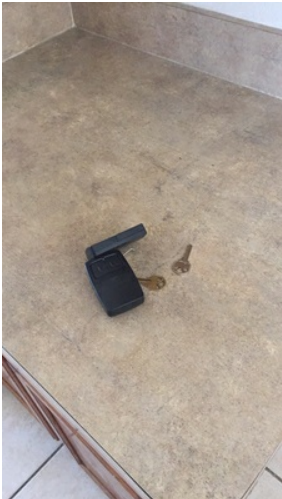
**Category:** MECHANICAL - Garage Door Opener & Remotes

**Comments:** Tenant left 2 remotes and spare keys. Garage door right side does not work, will need someone to repair.

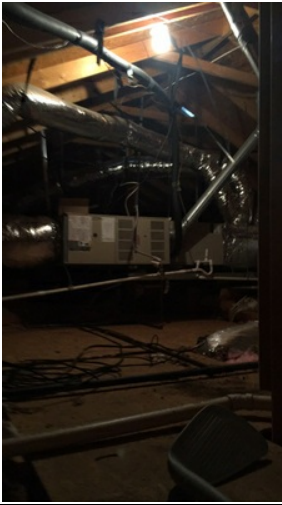
Category: MECHANICAL - HVAC

Condition: OK

Comments: Located in attic

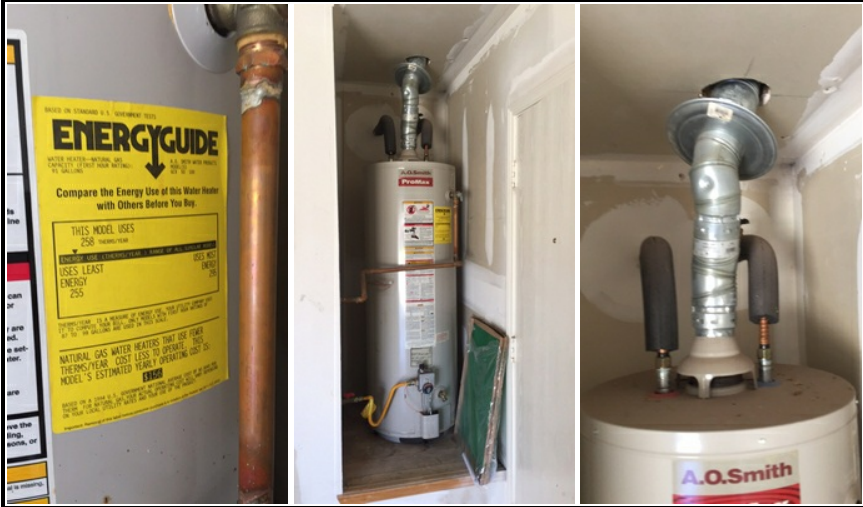
Category: MECHANICAL - Water Heater

Condition: OK

Comments: 50 gal gas water heater located in garage
