Property Evaluation Report

Property Address 2804 Goldfinch Dr Mesquite TX 75181-4923

Move-out

Evaluated By Trung Phung
Evaluation Date 15 March, 2017
Unit Name GOLD2804 - (2804 Goldfinch)
Lease Name DeLao - DeLao

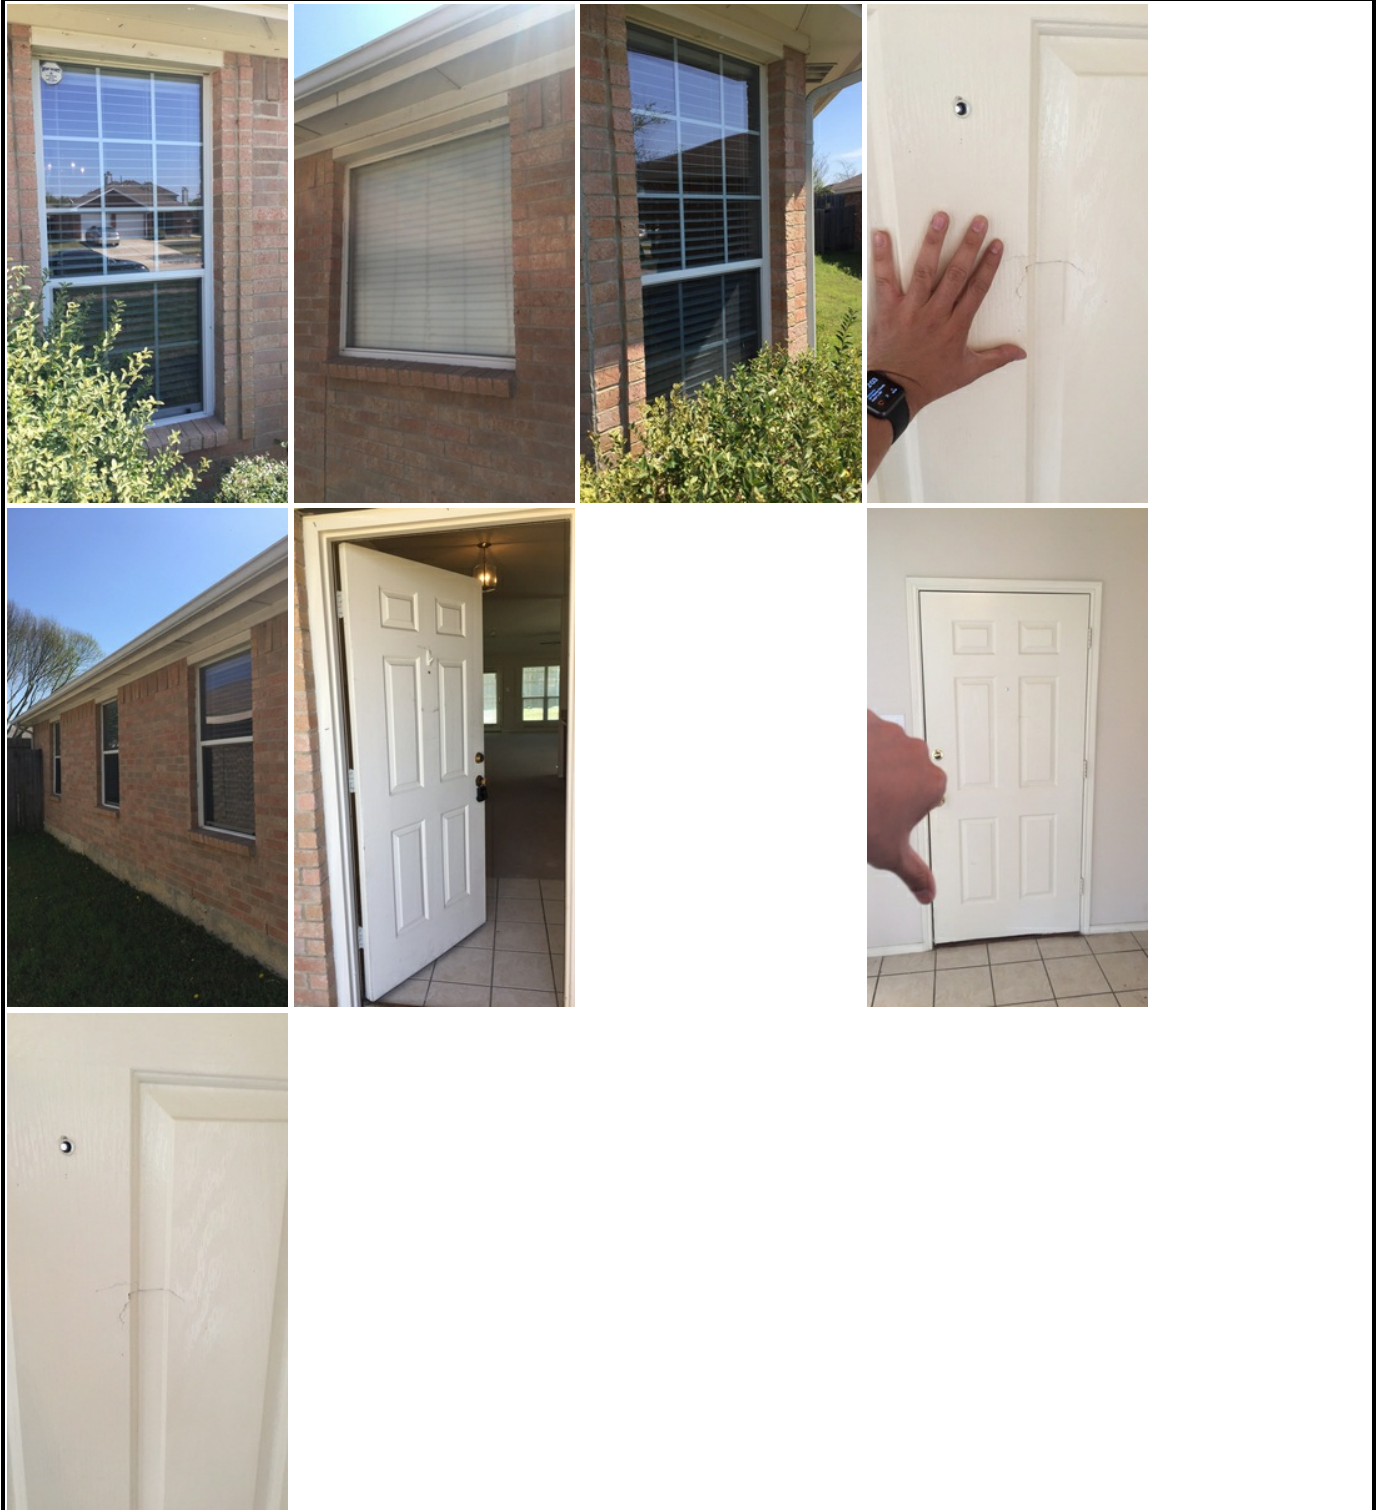
Category: EXTERIOR - Door/Windows

Condition: Repair

Comments: Will need to remove sticky hook off front door and repaint. All windows surrounding property are in great shape with screens.

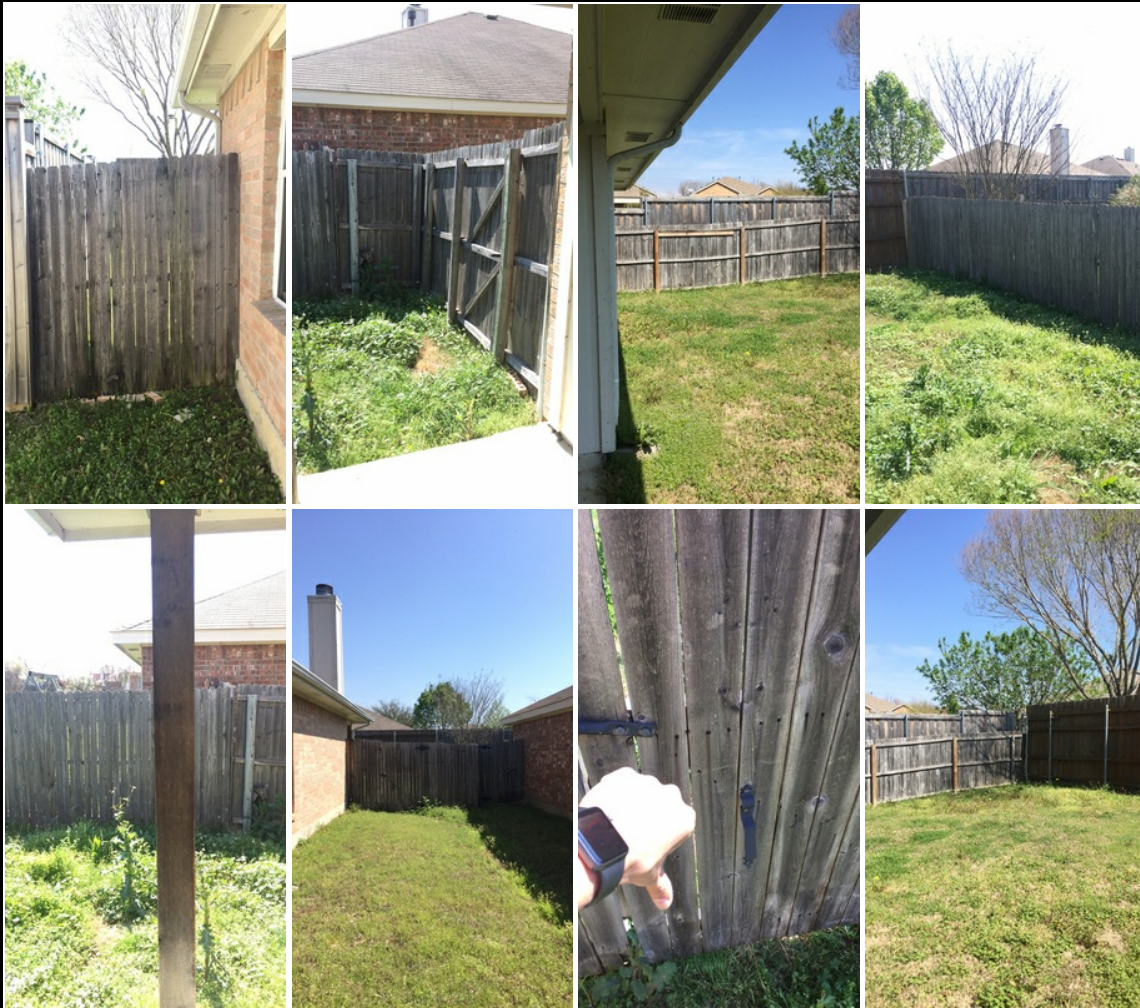
Category: EXTERIOR - Fence/Deck

Condition: OK

Comments: Gate handle needs to be reattached. Overall fence is standing; wood rotting. Would recommend future budgeting for fence repairs.

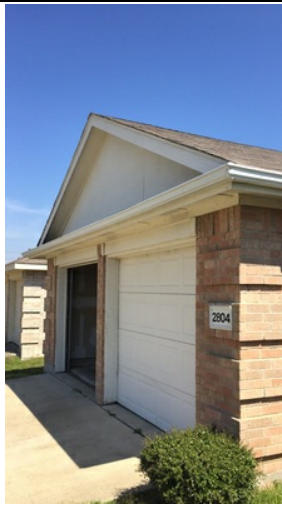
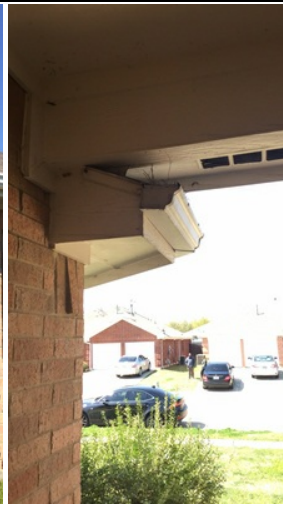
Category: EXTERIOR - Gutters

Condition: OK

Comments: Gutters are in good shape. Will need to remove birds nest in gutter on porch

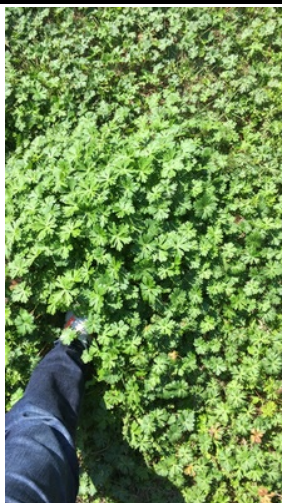
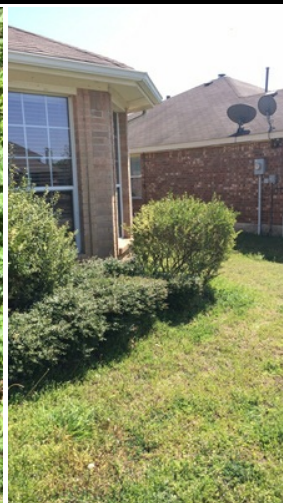
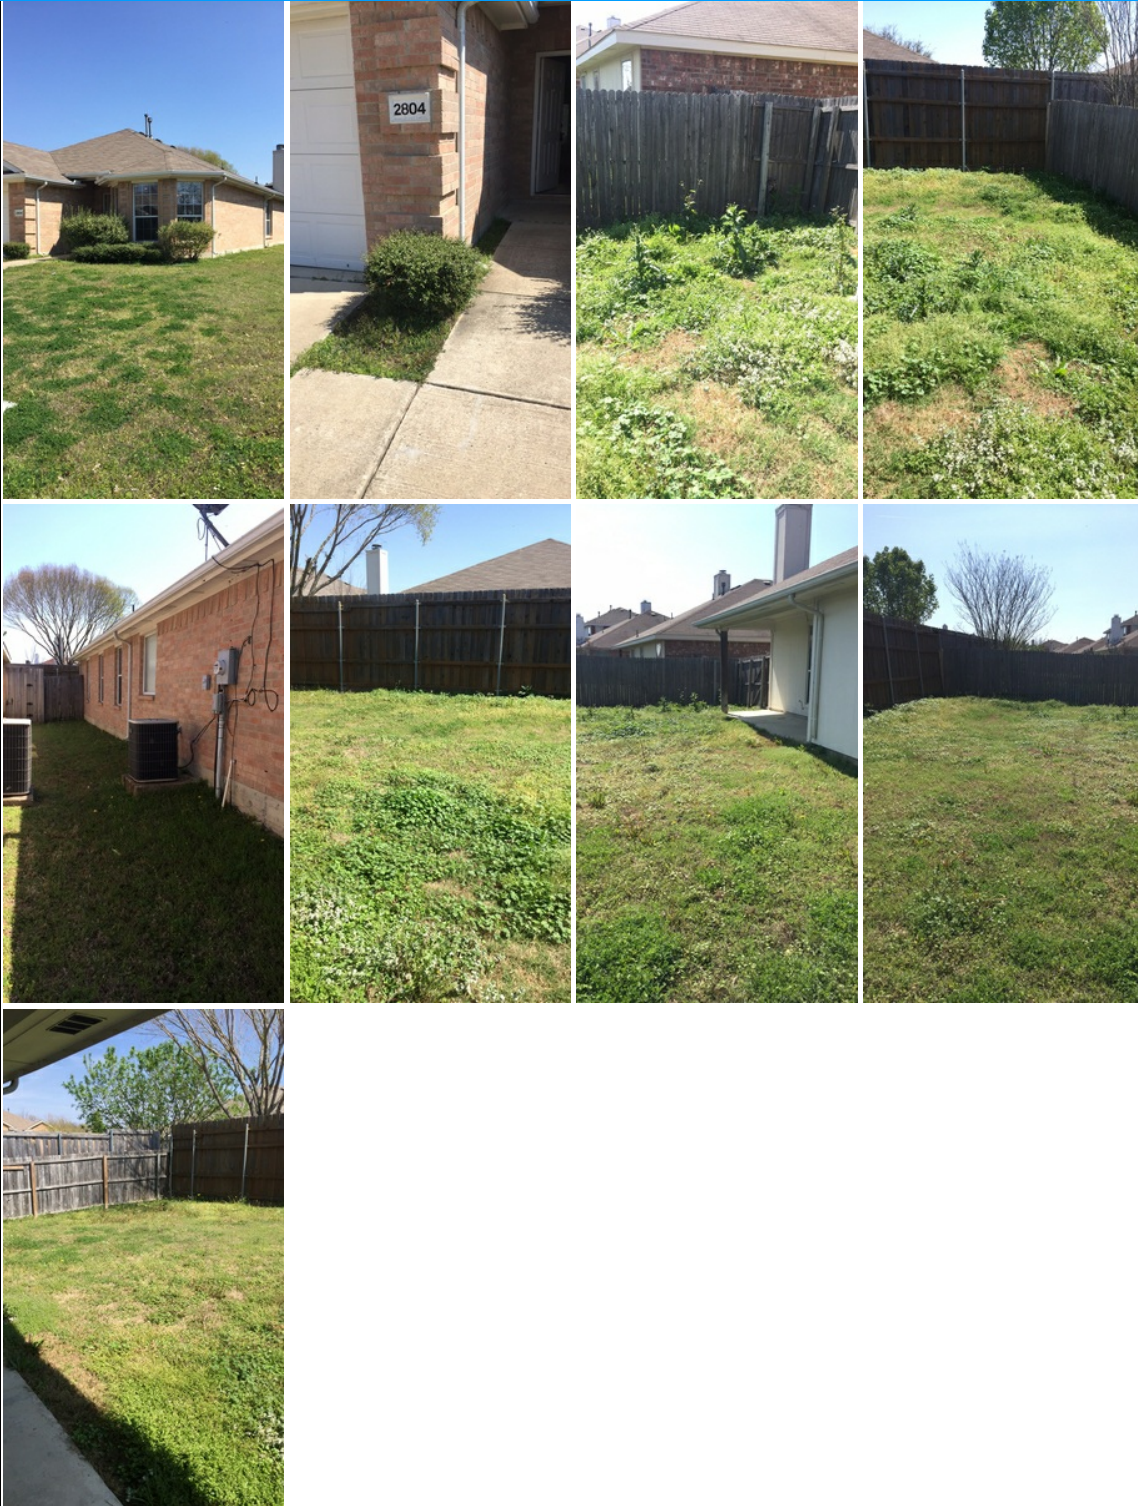
Category: EXTERIOR - Landscaping (Initial Cleanup)

Condition: Repair

Comments: Tenant did not perform landscaping duties prior to move out. Will need mow edge blow trim hedges remove weeds from flower bed and add red mulch.

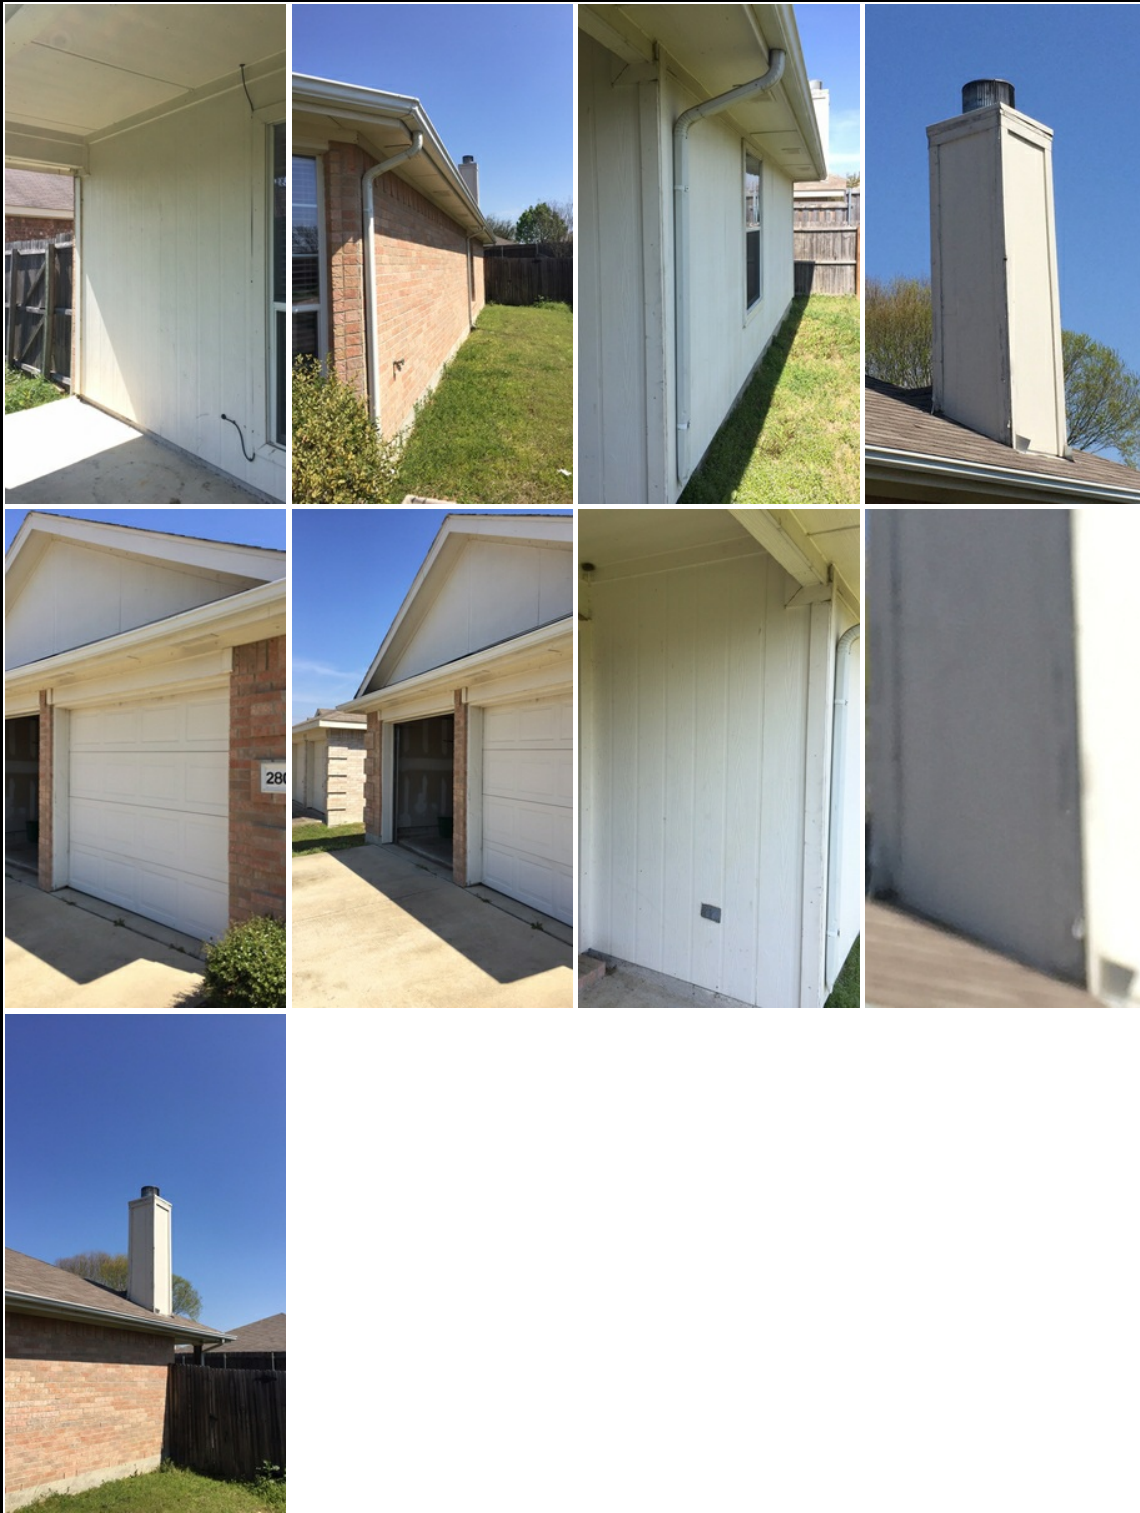
Category: EXTERIOR - Paint/Siding/Trim

Condition: Repair

Comments: Exterior paint looks good. Chimney paint is peeling/chipping away. Would recommend repaint.

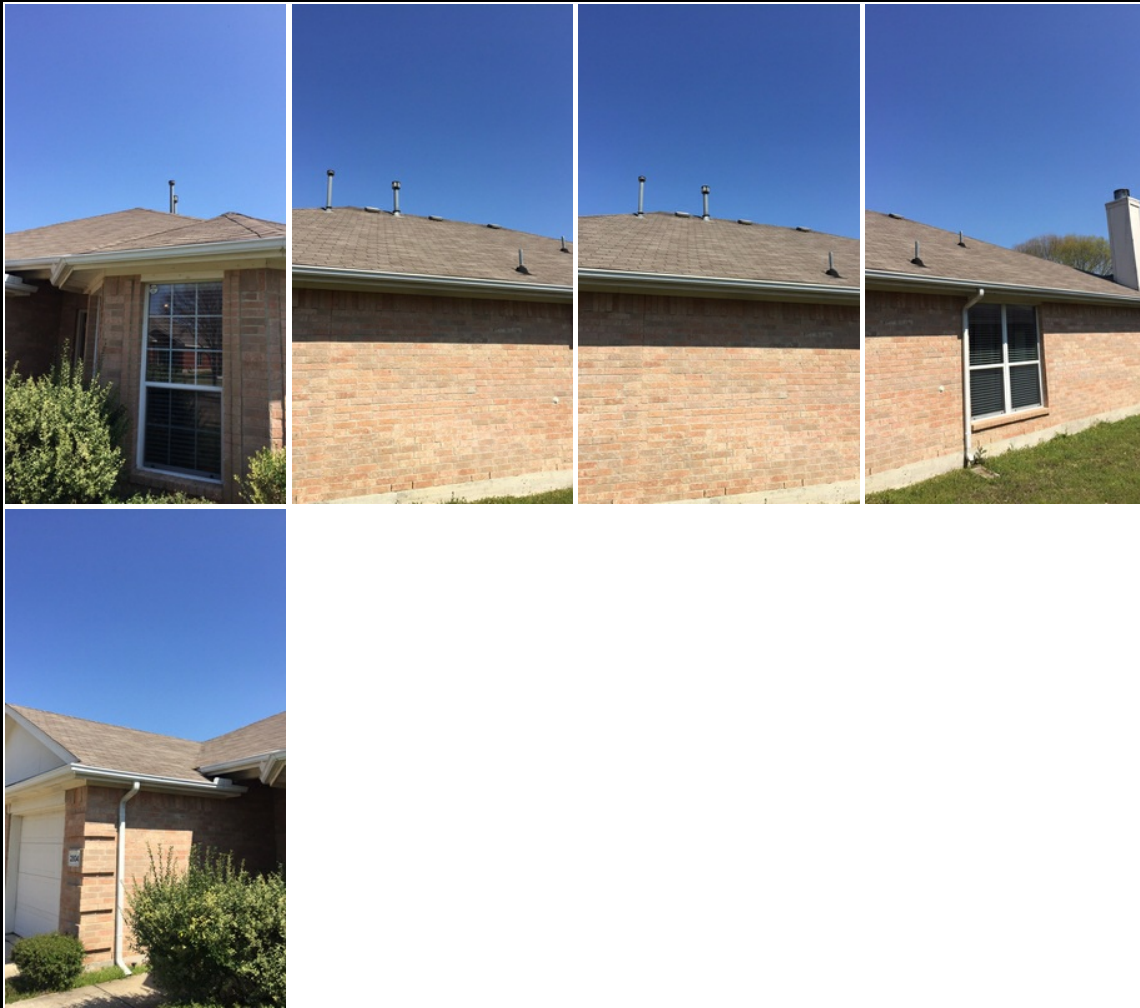
Category: EXTERIOR - Roof

Condition: OK

Comments: Roof looks good. No indication of water leaks in ceiling inside property

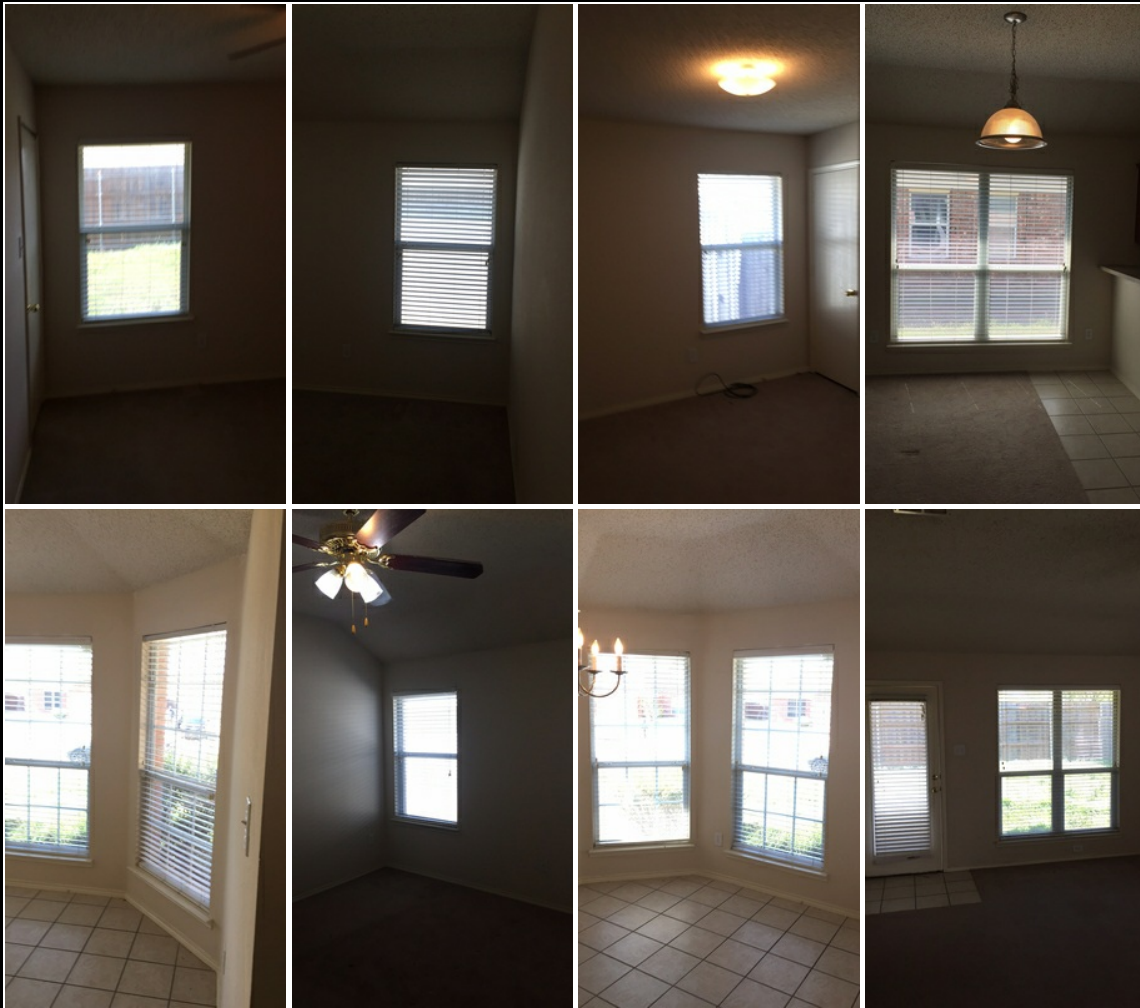
Category: INTERIOR - Blinds

Condition: OK

Comments: Blinds all throughout property in great shape; will need to dust and clean. Will be part of cleaning

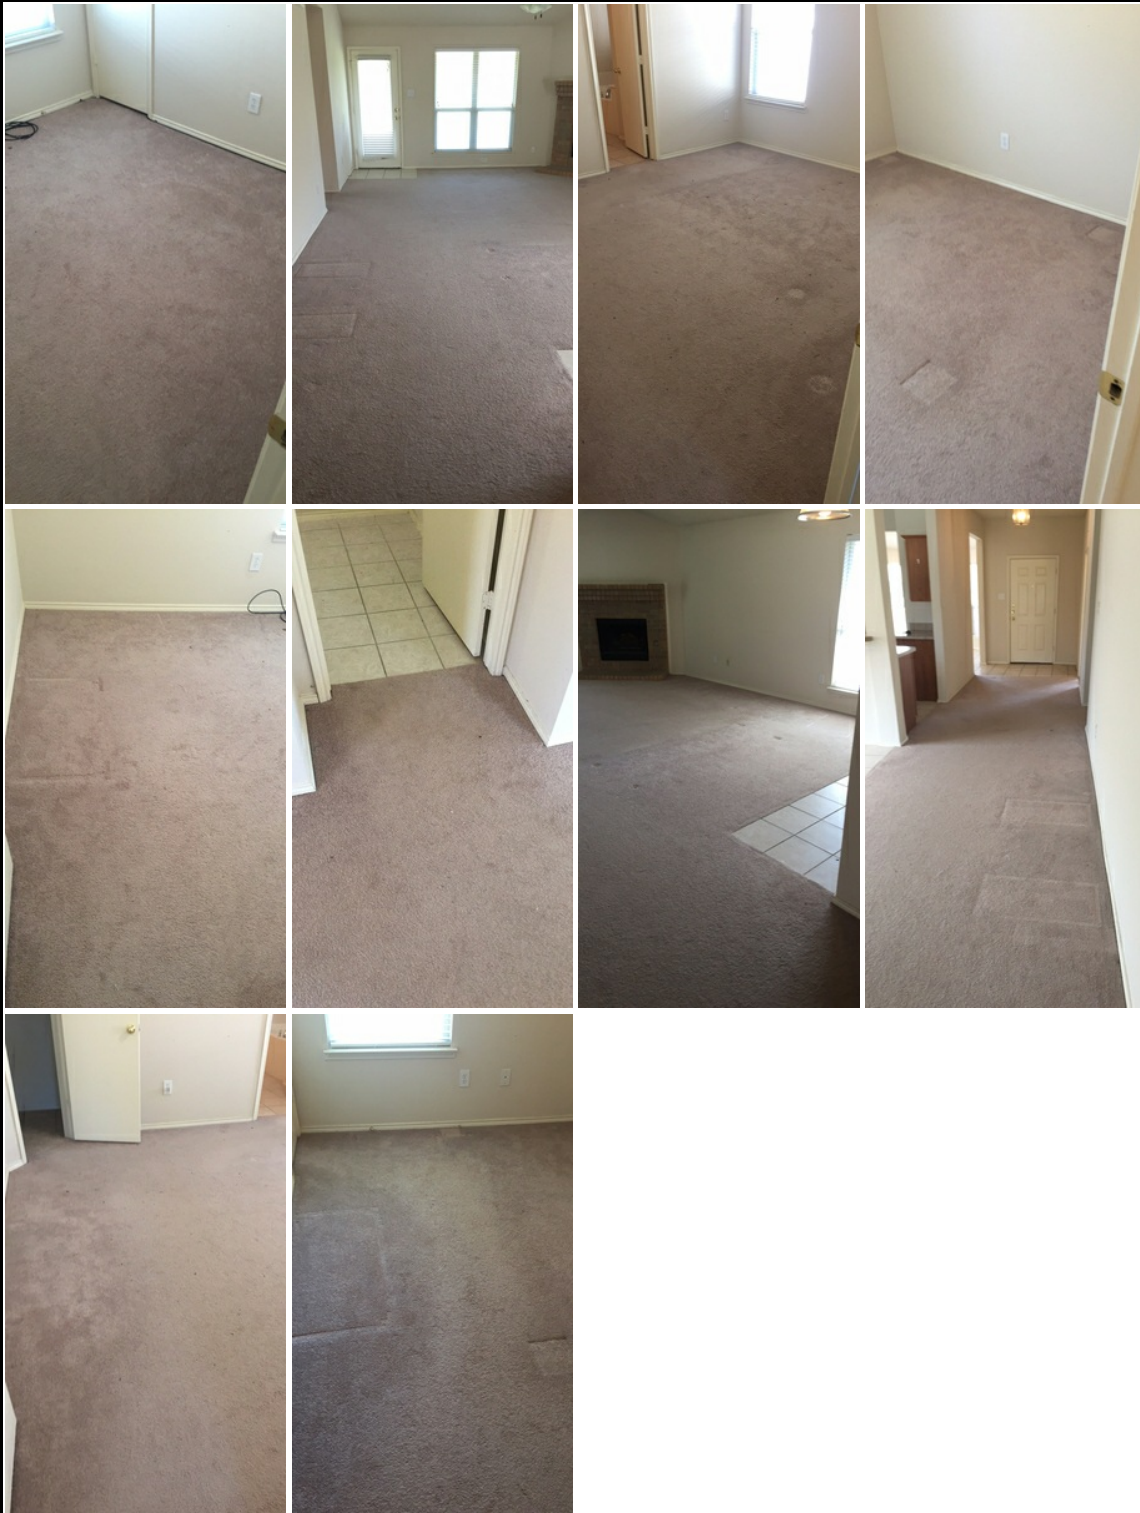
Category: INTERIOR - Carpet

Condition: OK

Comments: Carpet is in good shape. Tenant did not clean; will need shampoo during turnover.

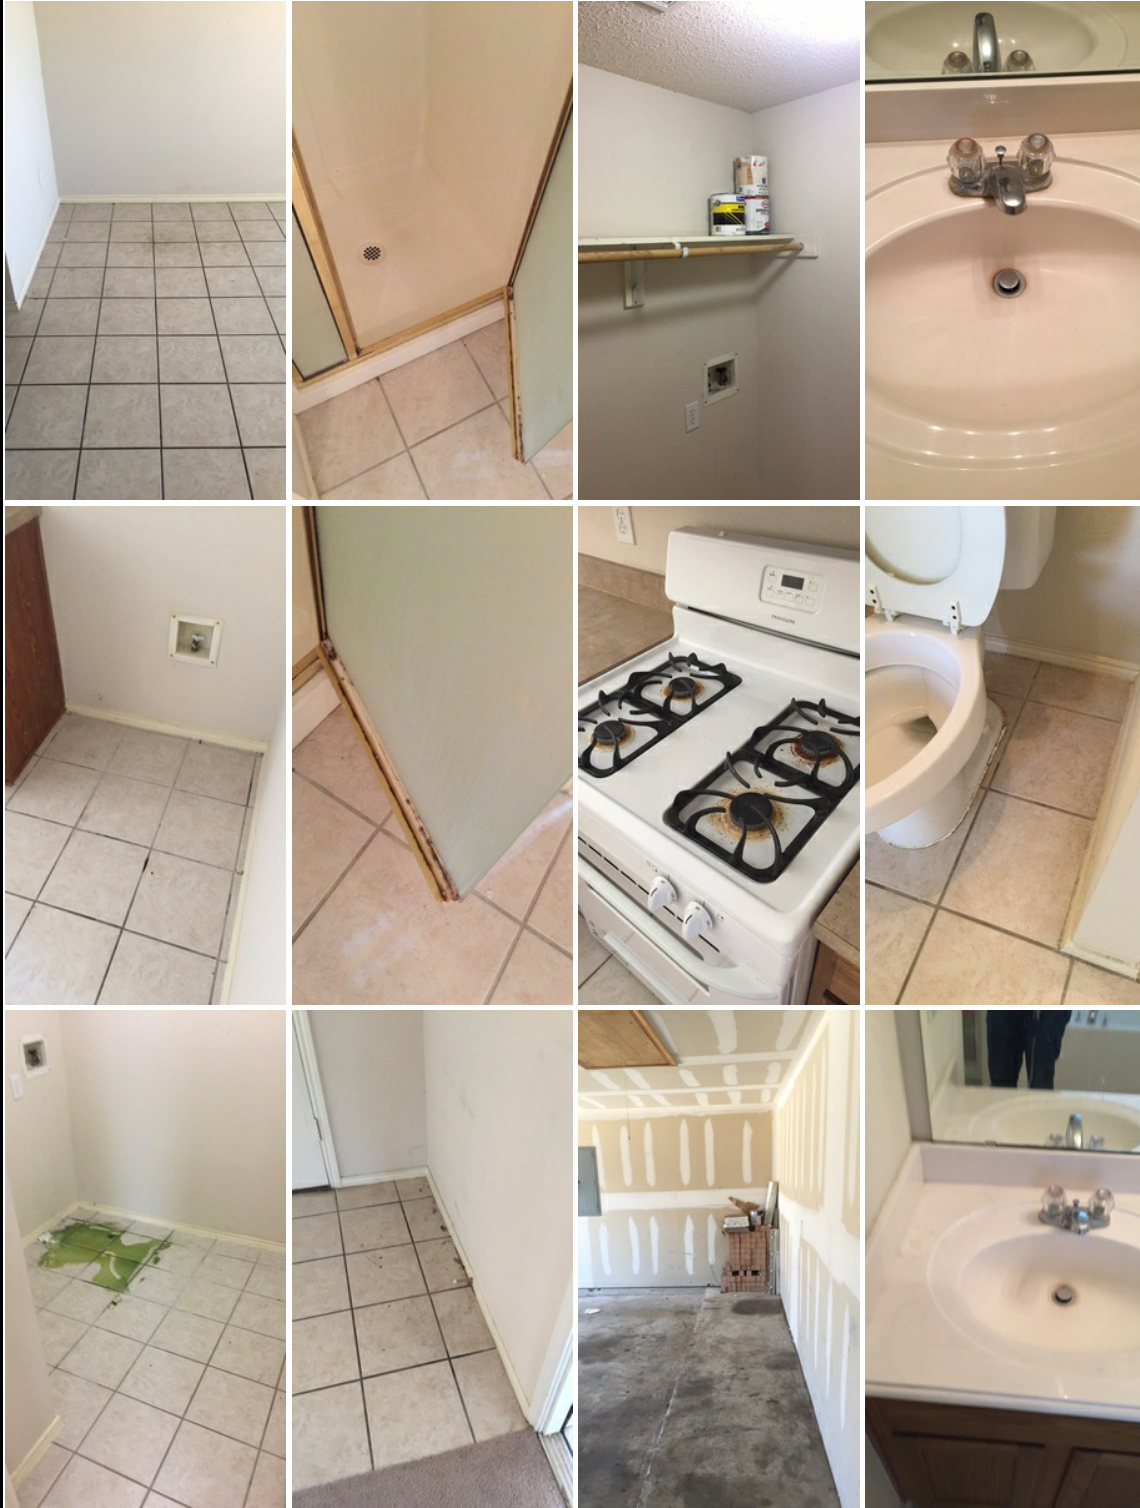
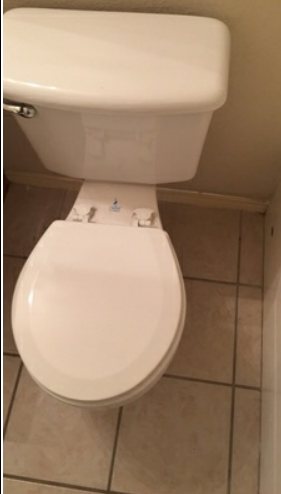
Category: INTERIOR - Cleaning

Condition: Repair

Comments: Tenant did not perform cleaning responsibilities prior to move out; will need final clean. Property left is overall good shape

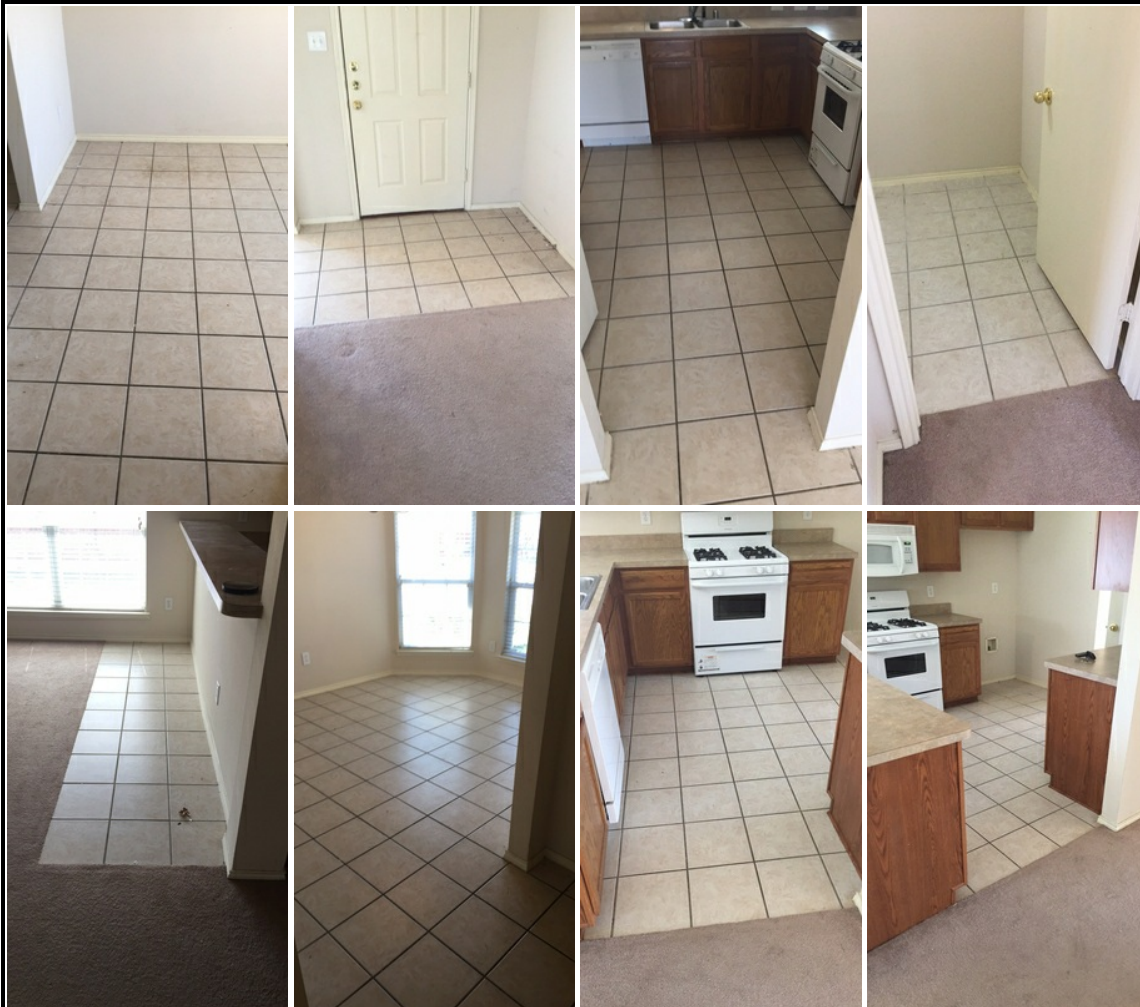
Category: INTERIOR - Hard Surface Flooring

Condition: OK

Comments: Tile in entry, dining room, kitchen, and bar space all in great condition.

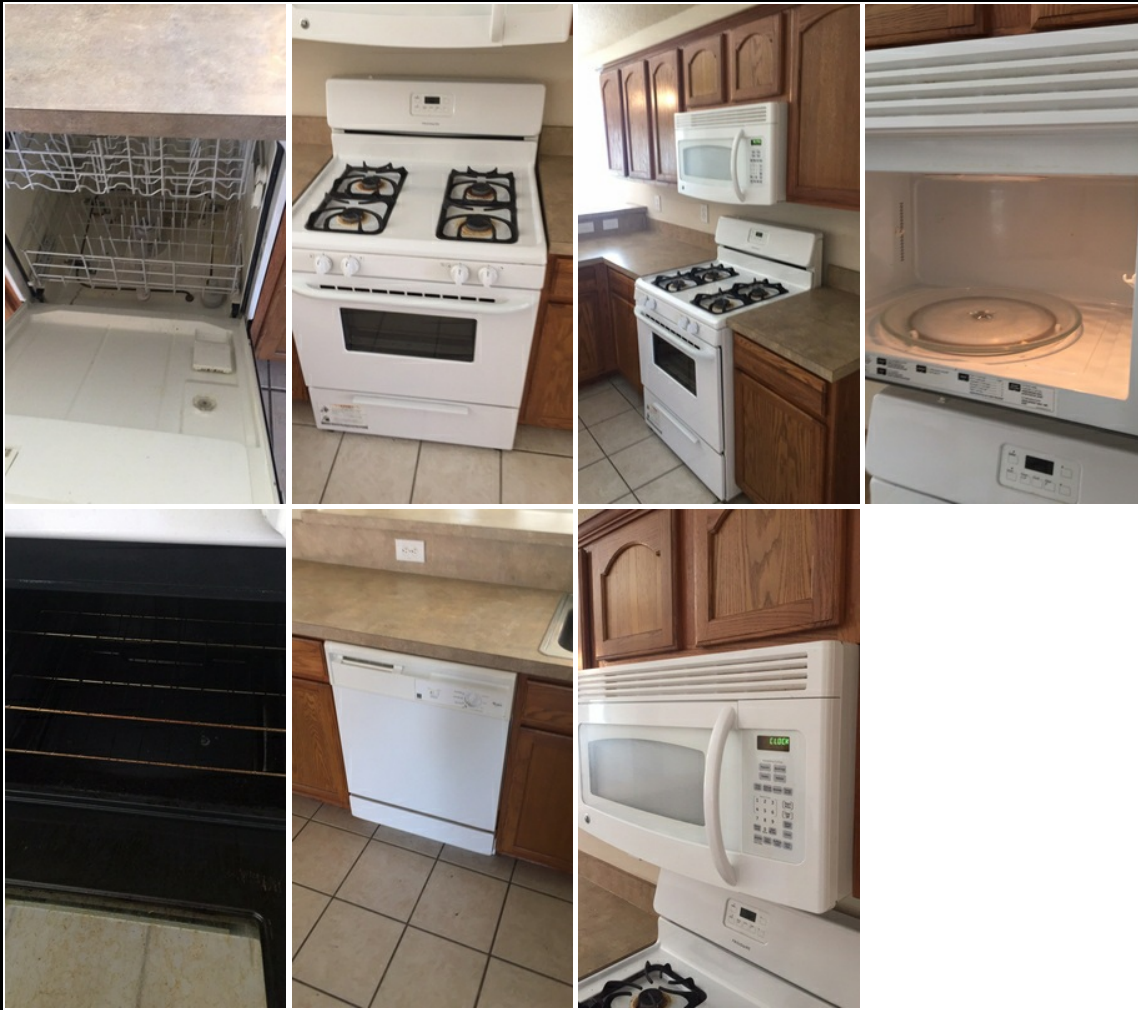
Category: INTERIOR - Kitchen Appliances

Condition: OK

Comments: All white appliances in good shape and condition

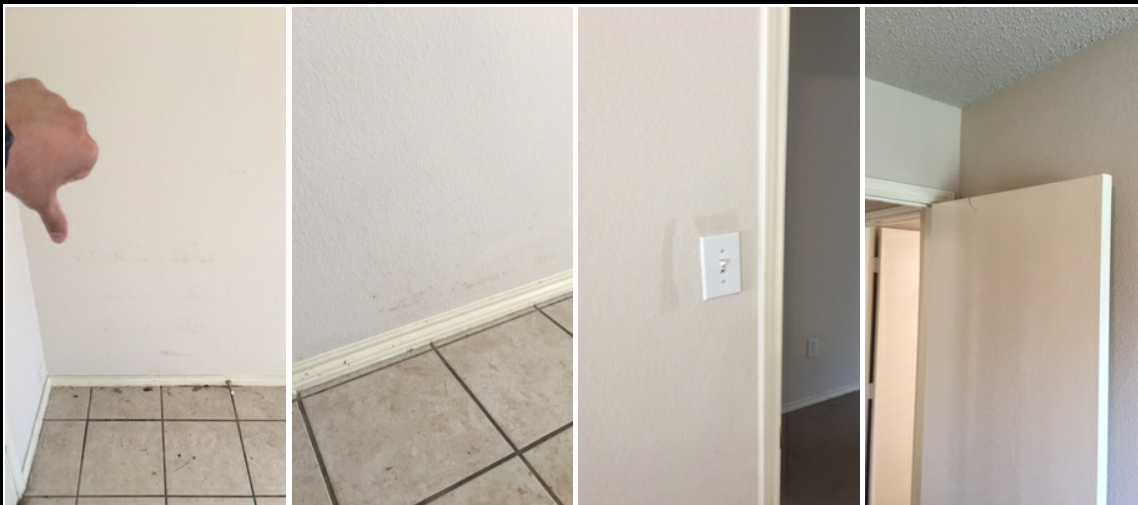
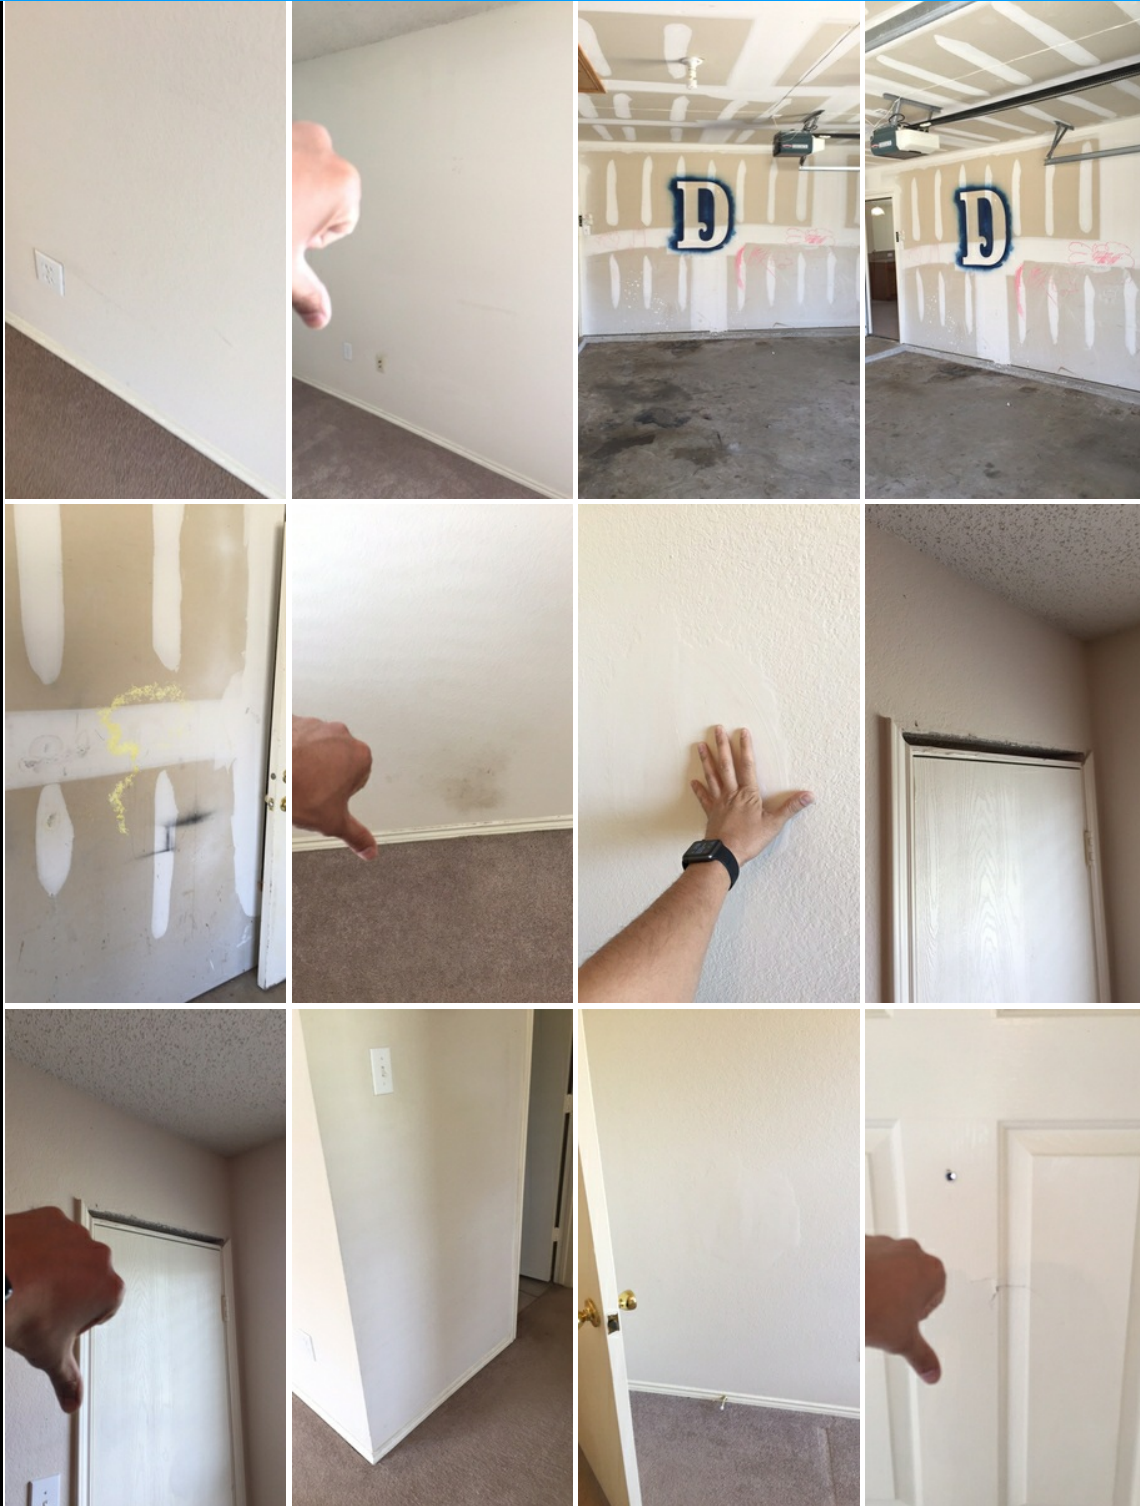
Category: INTERIOR - Paint

Condition: Repair

Comments: Light touch up; paint looks good. Normal wear and tear. Will need to repair in guestbedroom door; cracked top of door. Also need to repair trim for same bedroom closet door. Will need to repaint art work on garage wall; tenant chatge back.

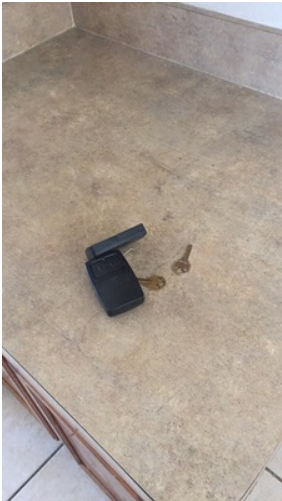
Category: MECHANICAL - Garage Door Opener & Remotes

Condition: OK

Comments: Tenant left 2 remotes and spare keys. Garage door right side does not work, will need someone to repair.

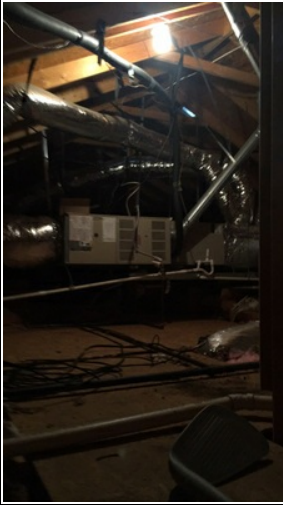
Category: MECHANICAL - HVAC

Condition: OK

Comments: Located in attic

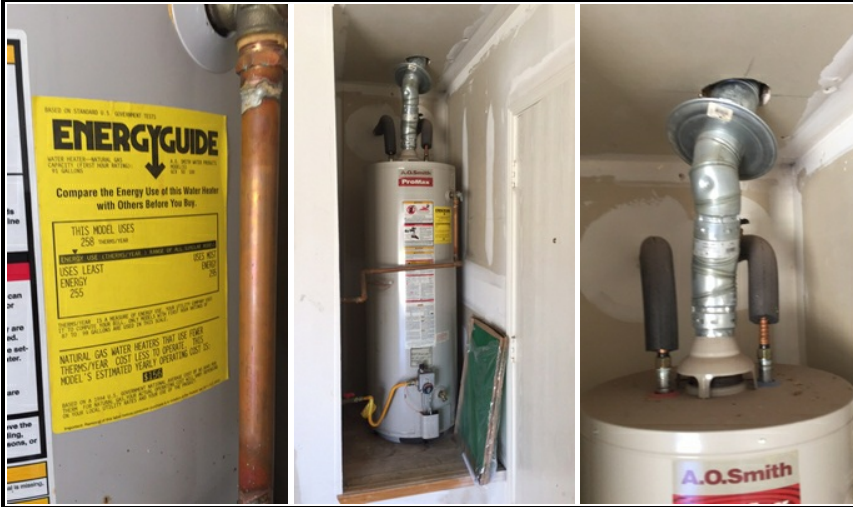
Category: MECHANICAL - Water Heater

Condition: OK

Comments: 50 gal gas water heater located in garage
